Eco-friendly production of waterborne paint

MUDP report

May 2021

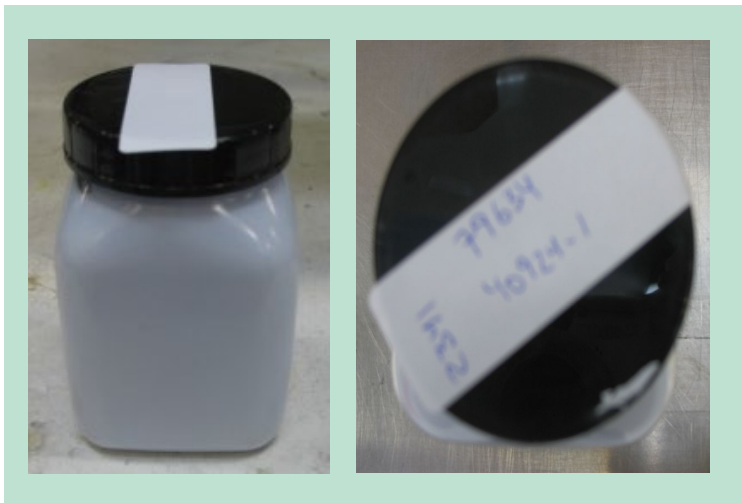
FIGURE 1. Reference samples from each produced batch of paint are collected in 250 mL plastic jars.

From each batch of produced paint, a reference sample is collected. The reference sample is taken in connection with the filling process. According to procedure, a small 250 mL plastic jar is filled after 50-100 buckets have been filled in the filling machine. The reference sample is identified by item number and batch number and stored at room temperature. Routinely, these reference samples are not tested for microbiology. Only in situations where there is a claim for rot, the reference sample for the specific batch is checked. Generally, these reference samples do not confirm contamination in a batch.

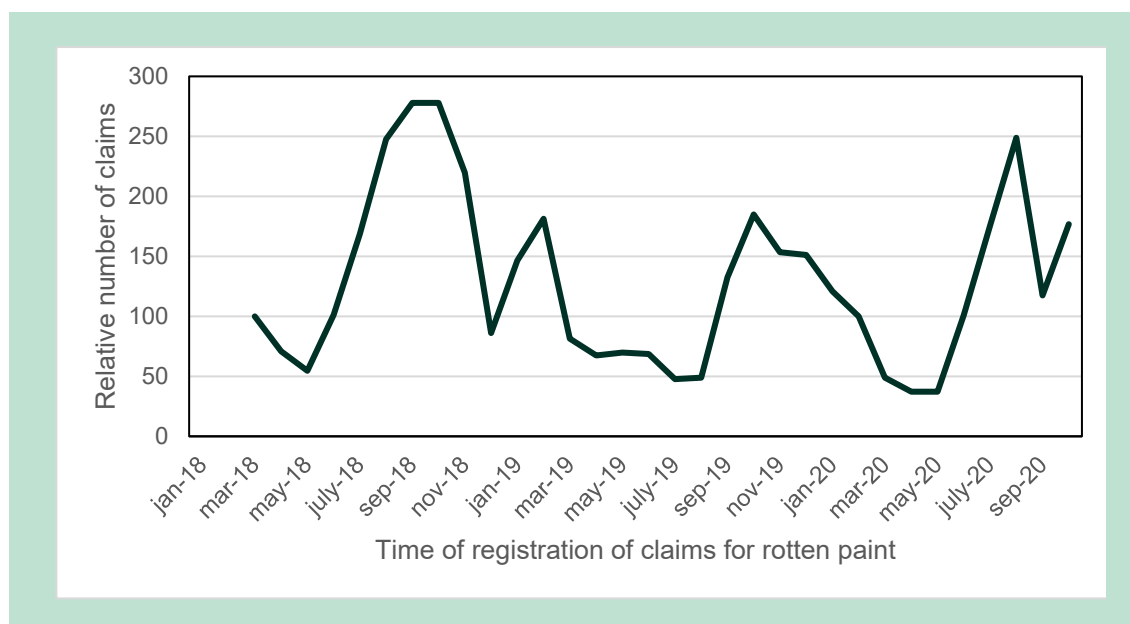
FIGURE 2. Relative occurrence of claim type ‘Rotten Paint’ recorded when received for items produced at the Flügger paint production plant in Kolding. March 2018 was used as index 100.

The most frequent claim type is ‘Rotten Paint’. FIGURE 2 shows the relative number of registered claims per month in 2018-2020 (only paint produced in Kolding) with the problem type Rot. From the time a batch of paint is produced and until a claim is received at Flügger, there is a natural delay. In FIGURE 3, the claim type ‘Rotten Paint’ is depicted as a function of production date showing that batches produced in June 2018 have the highest number of claims.

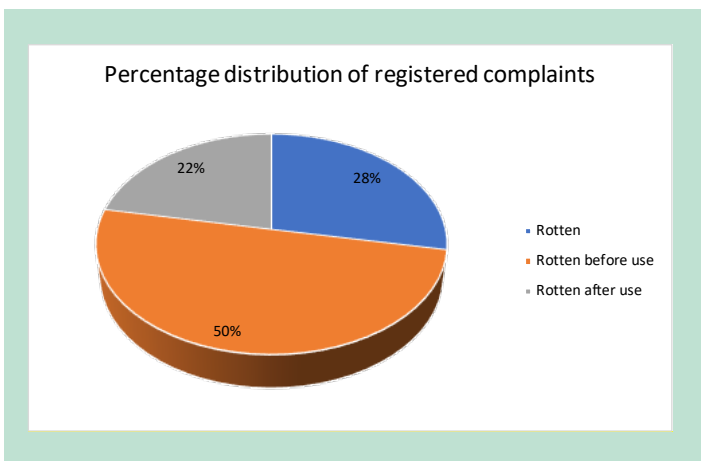
FIGURE 4. Relative number of registered claims for spoiled paint from January 2017 to December 2018.

Furthermore, registration shows that spoilage of paint seems to be linked to contamination during production and not by the end-user, as only 22 % of claims are registered as 'rotten after use', while 50 % are registered as 'rotten before use' FIGURE 4.

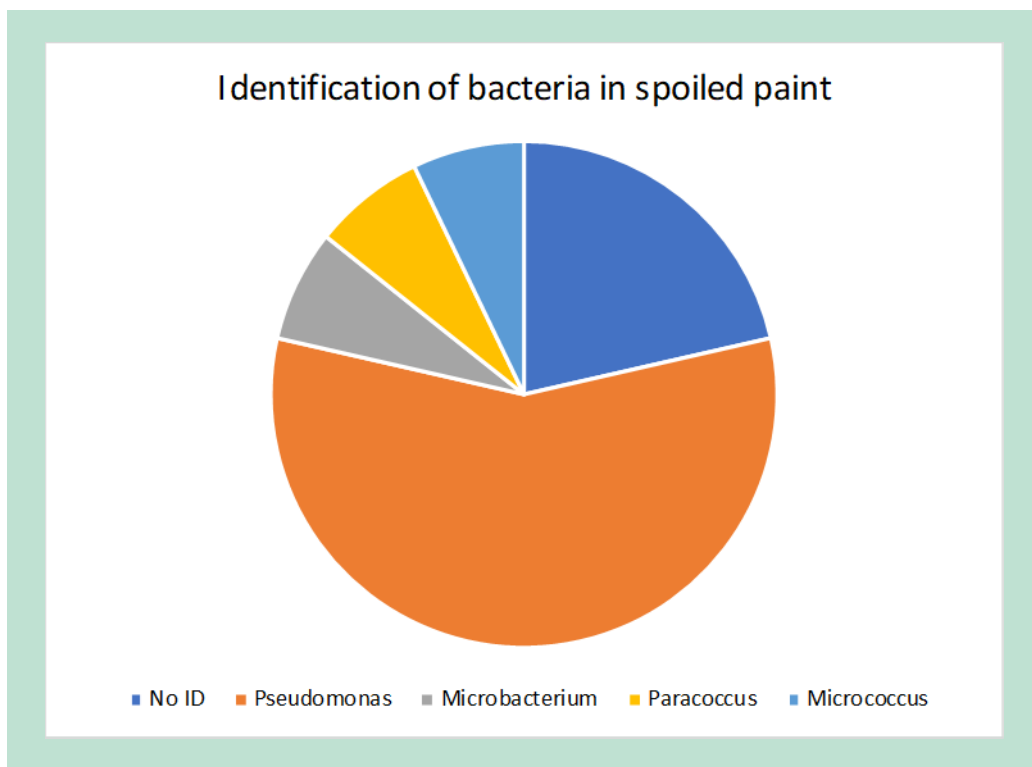
FIGURE 5. Identification of bacteria in spoiled paint performed using either 16S-rRNA sequencing or Maldi-TOF-MS on obtained pure cultures. A total of 14 samples were analysed.

In addition, some of the returned paints were subjected to microbiological analysis. The microbiological findings are given in FIGURE 5. Clearly, *Pseudomonas* is the one genus identified most often in the analysed spoiled paint.

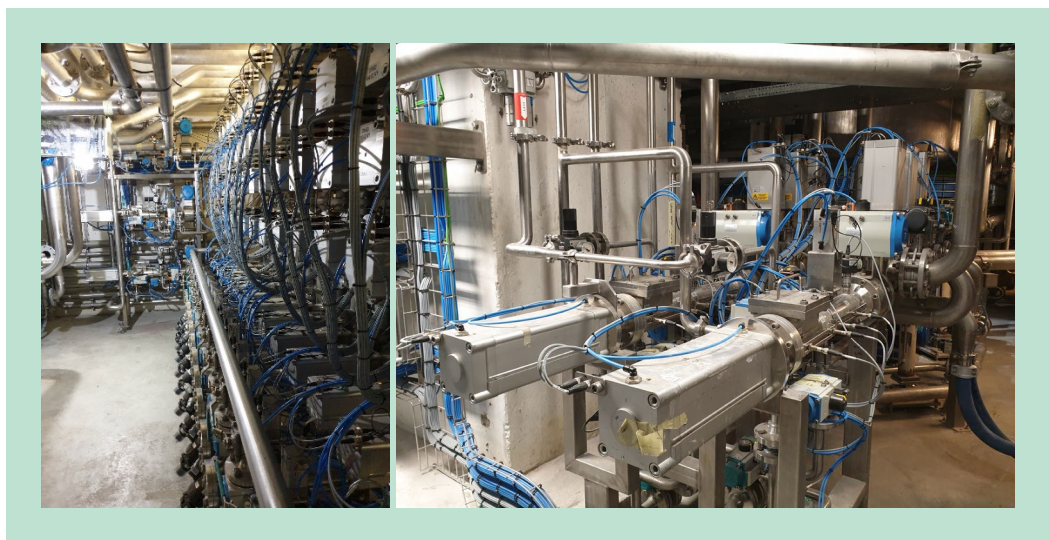
FIGURE 8. Details of renovated factory with filter station, station with pipes assigned for filling station and pipes prepared for optimal cleaning.

- Simplification of the piping system and plant layout under consideration of hygienic design principles.
- Design of novel automated pigging and cleaning stations based on the intermittent, experimental station investigated in WP1, allowing Flügger to use cleaning pigs in the whole piping system.
- Optimisation of cleaning procedures.
- New biological test method for quality control of selected raw materials.
- Further intensification of biological control of production equipment.
