The non-biological on-site treatment sys- tem

Final report for MUDP project

MUDP Report

February 2024

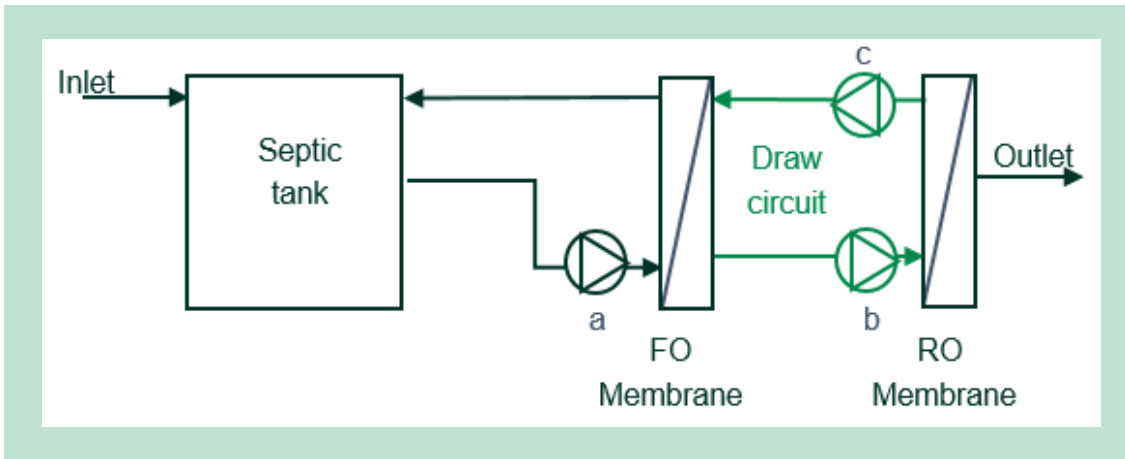
A feed pump (a) will recirculate wastewater from the septic tank to the FO membrane and return concentrate to the septic tank. A salt solution in the draw circuit will draw clean water out of the wastewater through the FO membrane. This will dilute the salt concentration, so to maintain the salt solution concentration, a high-pressure pump (b) will feed the draw solution to the RO membrane. Clean water will leave the system as permeate from the RO membrane and the up-concentrated salt solution (brine) will recirculate back to the FO membrane. The pressure energy recovery device (c) will reduce the outlet pressure from the RO membrane and use the recovered energy to save energy on the high-pressure pump (b).

FIGURE 1. Plant diagram with main components.

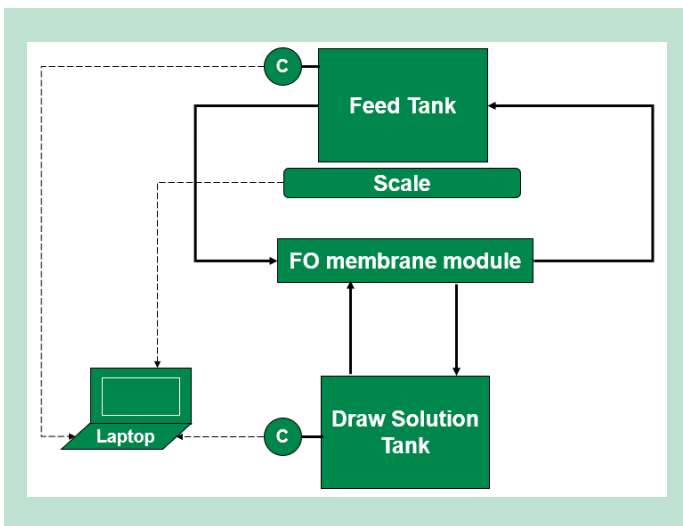
The pre-treated water was then filtered using a HFFO2 Aquaporin FO module. The test setup (FIGURE 2) consisted of a feed tank with prefiltered wastewater placed on a scale, an FO module, and a draw solution tank. Conductivity was measured both in the feed and in the draw solutions and was logged continuously. The weight data from the scale were used to calculate the water flux (J_w), the net volume of water that crosses the membrane per unit area and time, and the feed recovery, the percentage of the feed that is recovered as clean water.

FIGURE 2. Test setup for the evaluation of prefilter pore size and FO membrane suitability.

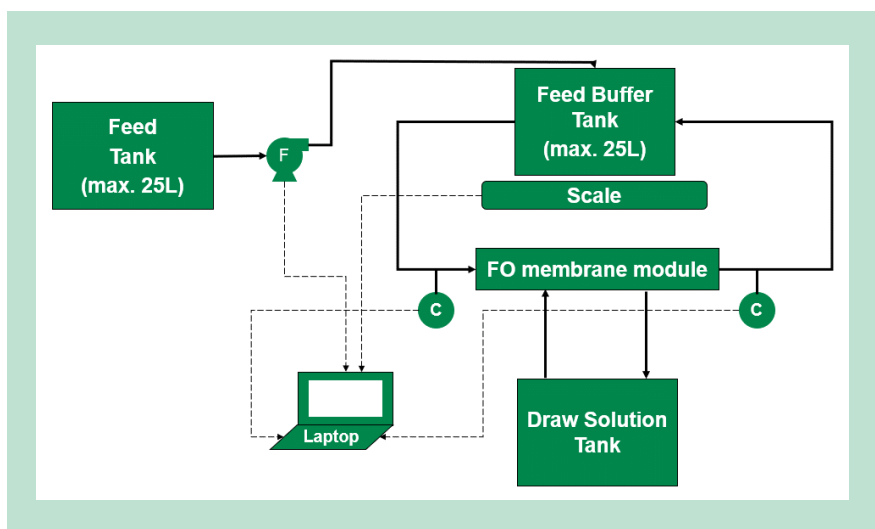
The test setup can be seen in FIGURE 4. Weight of the feed buffer tank and feed conductivity before and after the FO module were logged continuously. The test was run in duplicate, and the feed concentrate was characterised in terms of total solids (TS), total suspended solids (TSS), volatile solids (VS) and volatile suspended solids (VSS) and osmolarity (mOsmol/kg).

FIGURE 4. Test setup for the maximum recovery essay.

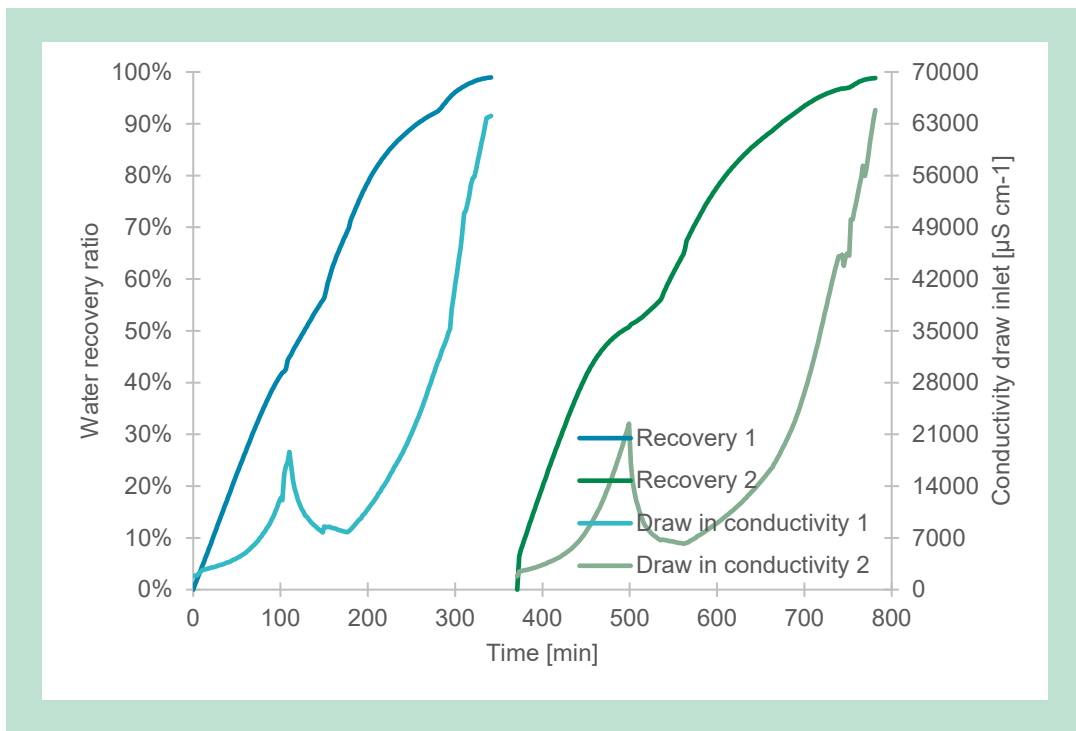
Each set started with app. 25 L of feed in the feed buffer tank. Starting from around 110 min (test run 1) and 500 min (test run 2) and the following 70 min – more feed was added with 0.346 L min⁻¹. In total 50080 ml were concentrated to 529 ml in test run 1 and 47794 ml were concentrated to 582 ml in test run 2. Corresponding to 98.9% and 98.8% water recovery ratio. 3x25 L of draw solution 1 M NaCl was used for test run 1 and 4x25 L of draw solution 1 M NaCl for test run 2. The corresponding developments in water recovery rates and draw inlet conductivities can be seen in FIGURE 5.

FIGURE 5. Maximum recovery test run 1 and 2.

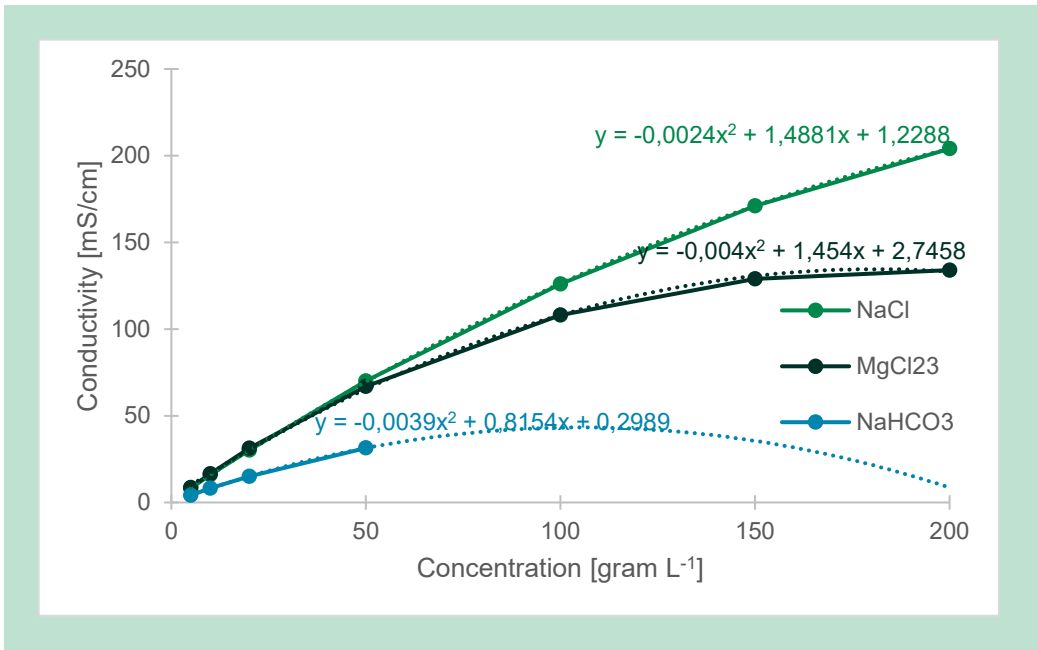
The correlation between salt concentration and conductivity were approximated, using data from CRC handbook and equations fitted using Matlab. See FIGURE 6.

FIGURE 6. Correlations used between conductivity and salt concentrations.

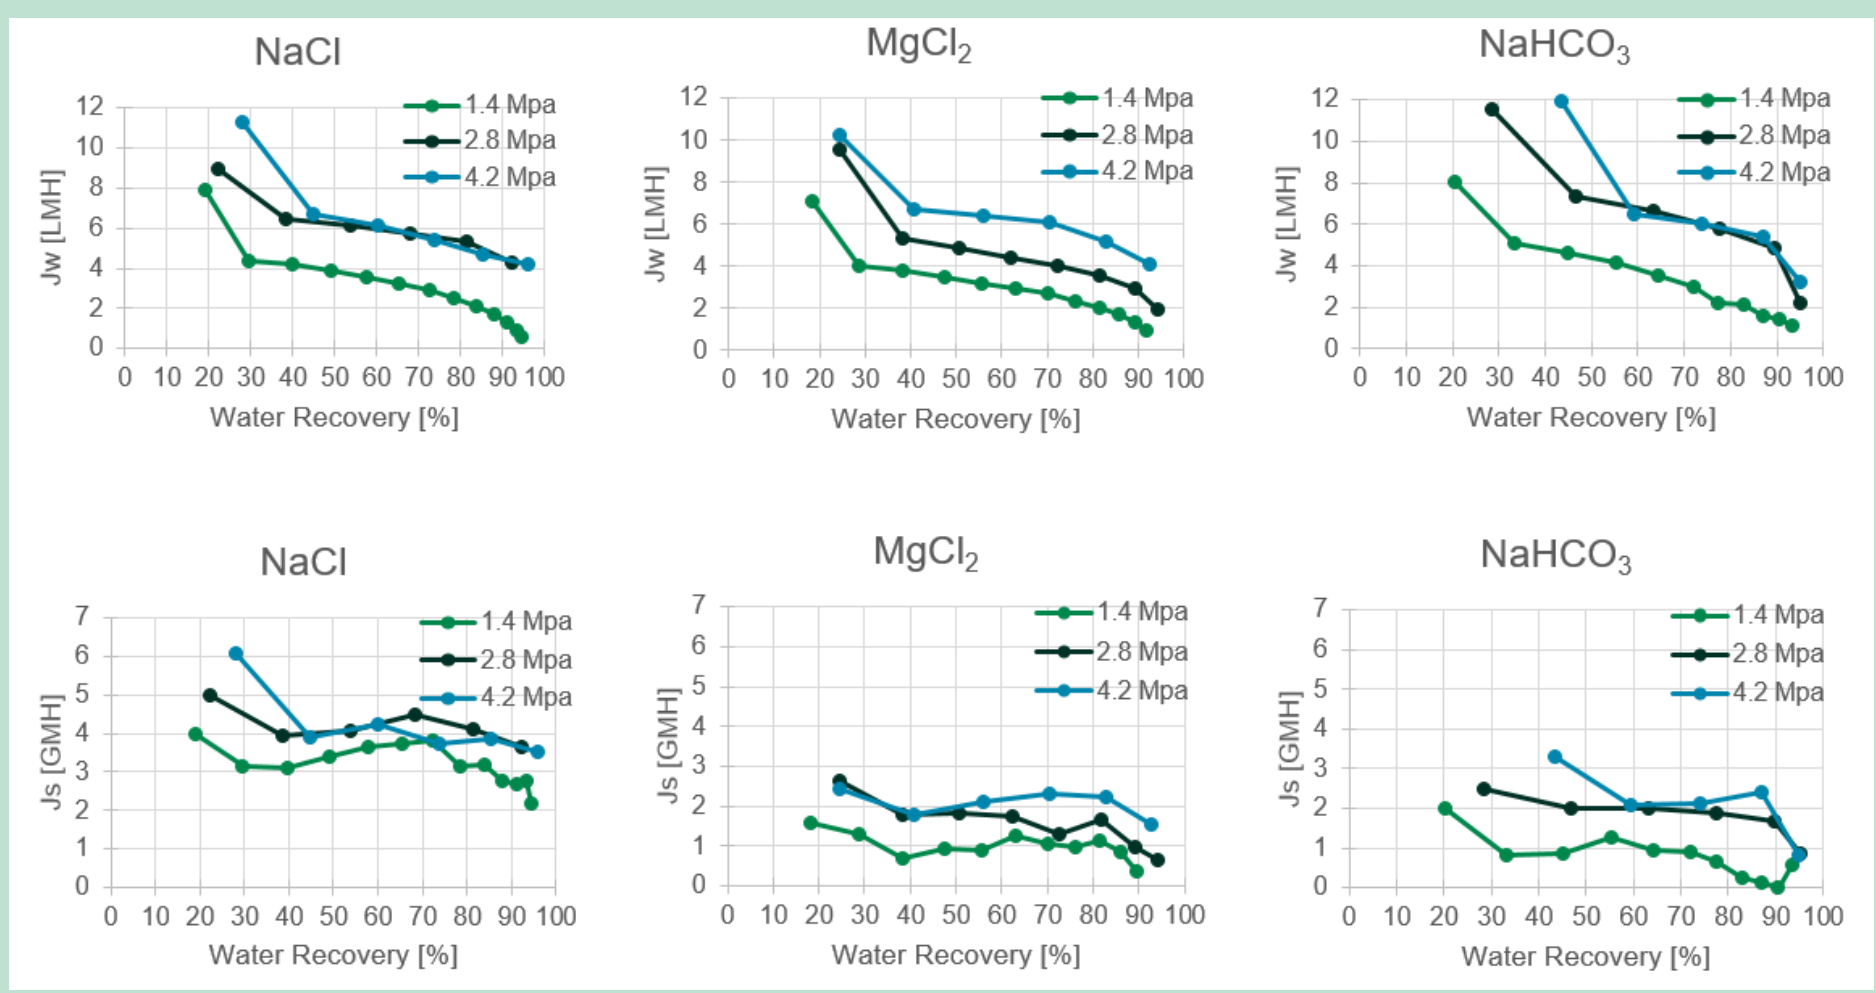
The results are seen in FIGURE 7. Recovery rates between 94 % and 96 % were obtained for all treatments. Overall, the water fluxes are similar for all salts, even though results show some irregularities for the 2.8 MPa draw solution tests. As can be seen, the reverse salt flux is lower for MgCl₂, which would result in lower salt loss and less frequent salt refill. The relative reverse salt flux for MgCl₂ is around 0.1-0.2 g L⁻¹ for the three tests, compared to 0.3 – 0.5 g L⁻¹ for NaCl.

FIGURE 7. Water fluxes (LMH = L m⁻² hour⁻¹) and Revers salt fluxes (GMH = g m⁻² h⁻¹).

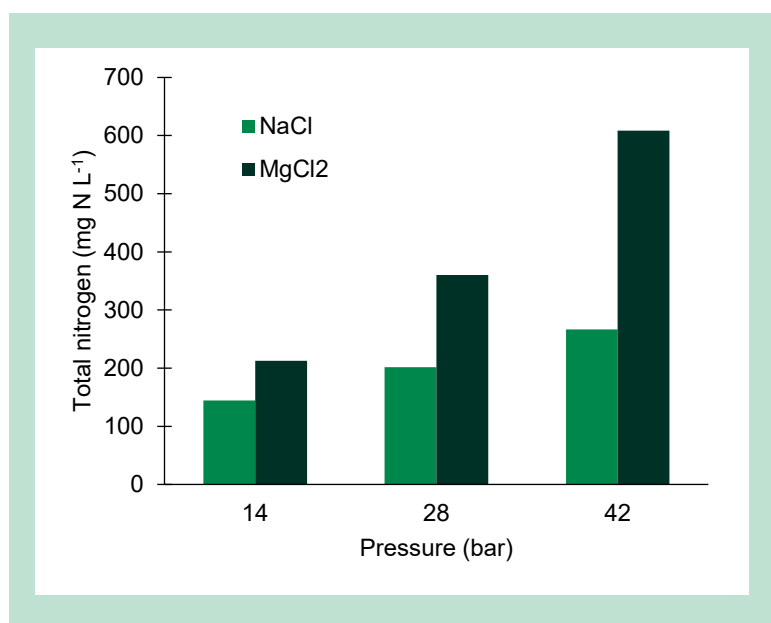
A big difference is in the ammonium rejection. The concentration of nitrogen in the concentrated feed, shown in FIGURE 8, is an indication of the rejection: the higher it is, the higher the rejection is, too. A high rejection is desirable, since ammonium passing to the draw solution deteriorates its quality and may pose a challenge for the final outlet quality. Ammonium rejection increases with increasing osmotic pressure for both salts, but it does so much more starkly for MgCl₂.

It is well-known from other studies [2] that ammonium forward flux increases with draw solute reverse salt flux, as the sodium ions facilitates active transport of ammonium ions to the draw side. Therefore, rejections are lower for NaCl compared to MgCl₂.

FIGURE 8. Total nitrogen concentration in the concentrated feed at different osmotic pressures.

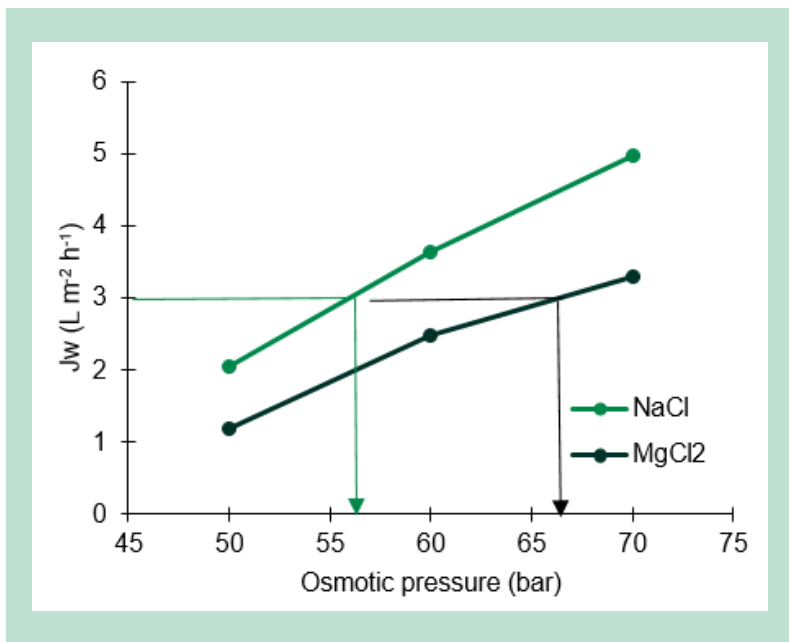
The above tests stopped at lower recovery rates than 99% therefore, a test was performed with the aim of getting an idea of the necessary osmotic pressure difference at the end of a full cycle (99% recovery) to maintain a flux. Considering that the feed is expected to reach 40 bar osmotic pressure, osmotic pressures of 50, 60 and 70 bar were tested. The test was performed on simulated salt solutions with similar osmolarity as the up-concentrated wastewater from Herlev Hospital following the test setup in FIGURE 9.

FIGURE 9. Water flux (J_w) as a function of osmotic pressure. The arrows indicate the osmotic pressure needed at the end of the cycle to achieve $3 L m^{-2} h^{-1}$.

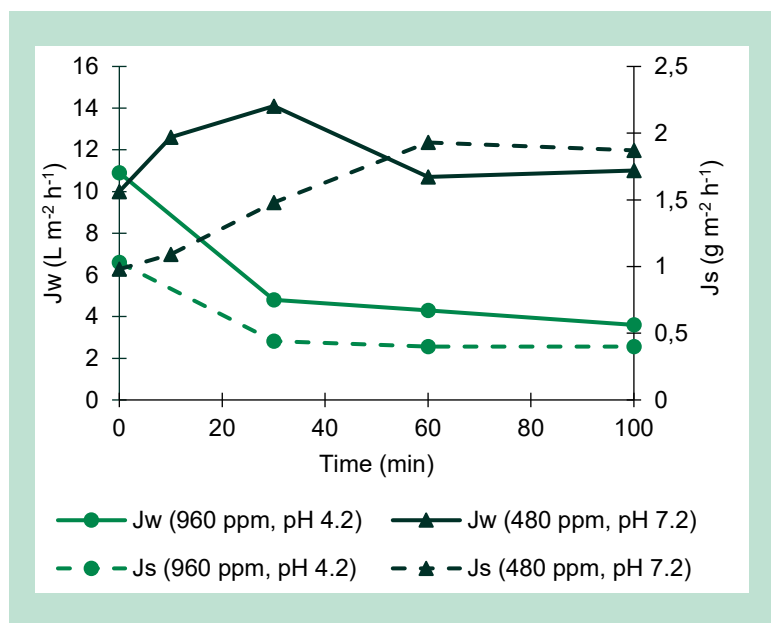
As can be seen in FIGURE 10, 420 ppm Neuthox® at pH 7.2 shows a better overall performance than 960 ppm Neuthox® at pH 4.2. J_w remains stable over time, and J_s is still in an acceptable range below $2 \text{ g m}^{-2} \text{ h}^{-1}$ despite an almost doubling over time. The increased reverse salt flux is of course undesired, but 960 ppm Neuthox® causes the J_w to drop to around 1/3 of the original J_w .

The results show two opposite effects on the polyamide layer. At pH below 7, addition of chlorine to the polyamide matrix results in a tightening of the pores and a consequent lower water flux. At pH above 7, hydrolysis by chlorine results in a less cross-linked and more hydrophilic membrane, with a subsequent higher water flux, but lower rejection rates and a higher reverse salt flux [3].

FIGURE 10. Short-term exposure test of the FO membrane to two Neuthox® solutions: 960 ppm at pH 4.2 and 420 ppm at pH 7.2. J_w is the water flux and J_s is the reverse salt flux

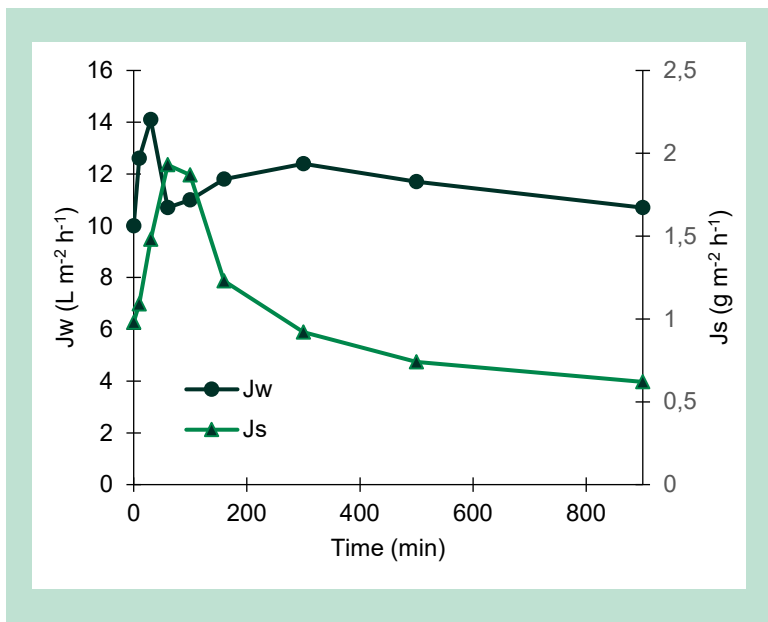
FIGURE 11 shows that water flux remains very stable over time, and the reverse salt flux falls back to a very low level, which is good. Thus, it was concluded that a Neuthox® at 420 ppm and pH 7.2 is an acceptable candidate for biocide treatment.

FIGURE 11. Water flux (J_w) and reverse salt flux (J_s) as a function of time for Neuthox ® 420 ppm and pH 7.2.

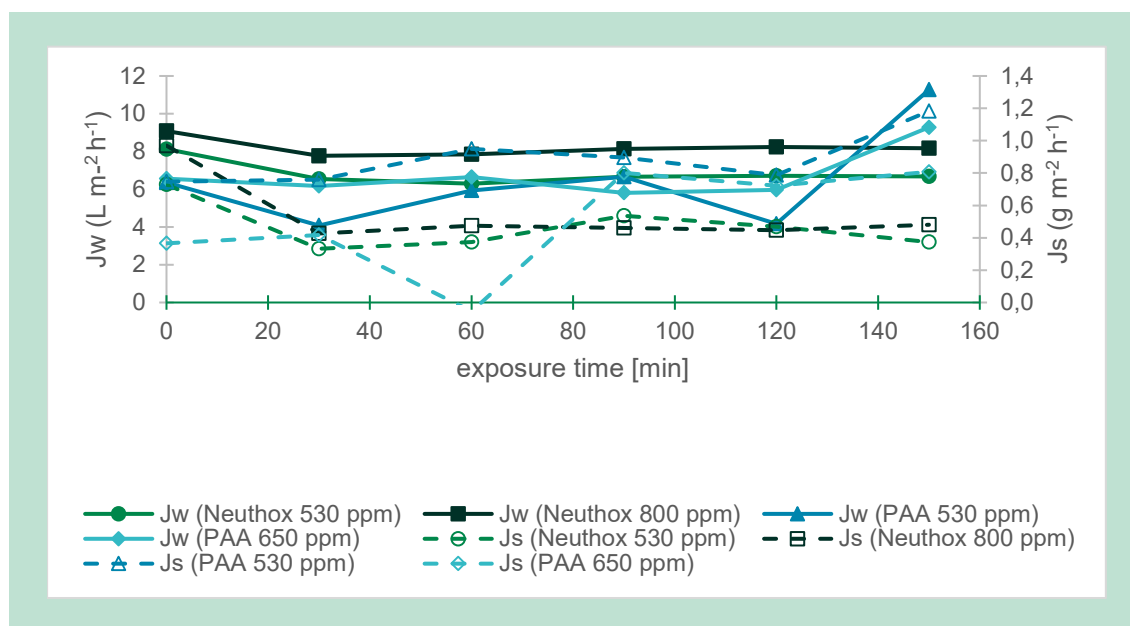
Overall, most of the tested biocides seem to impact membrane hydrophilicity and reverse salt flux in the first 25 – 60 min of exposure and then the values stabilize. Therefore, long term testing is needed to fully see the effect of each biocide.

FIGURE 12. Biocide screening based on water flux (J_w) and reverse salt flux (J_s).

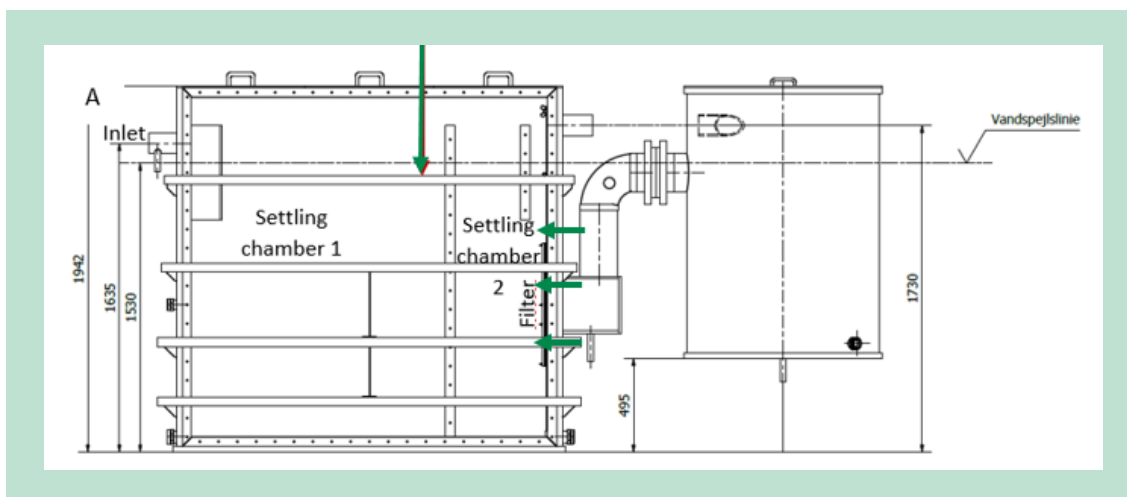
FIGURE 14. Sampling location in septic tank.

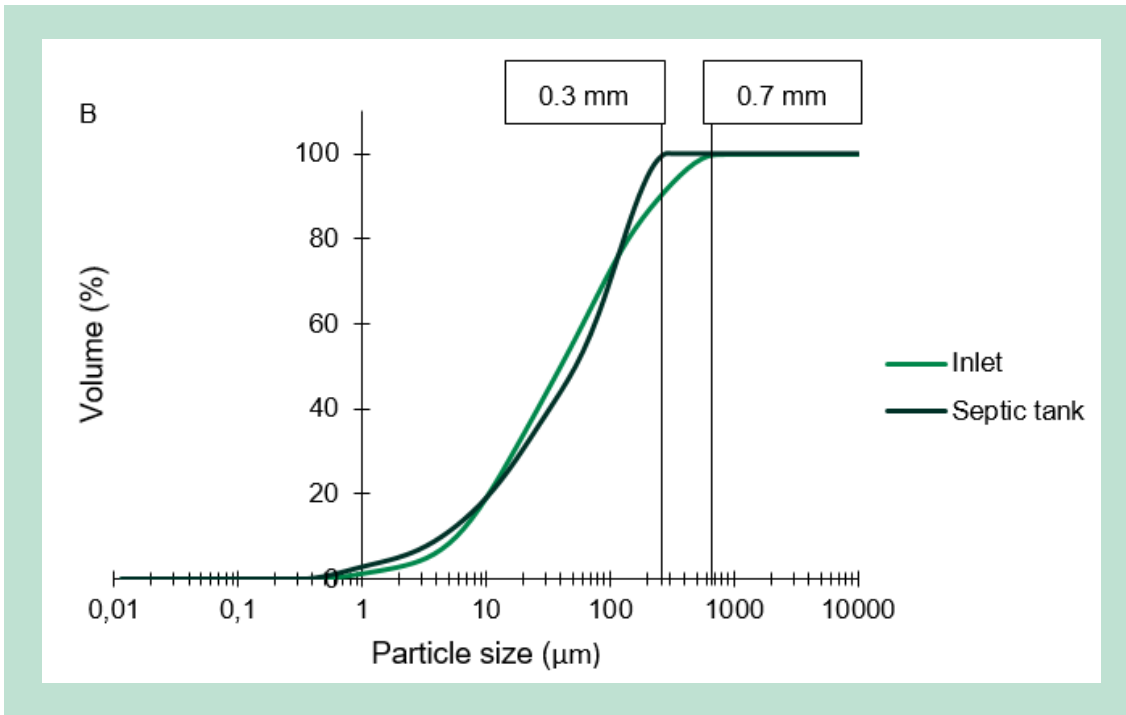
FIGURE 15 shows the particle size distribution in the raw wastewater inlet and in the septic tank in chamber 1. The inlet contains particles up to 0.7 mm in diameter, while the liquid fraction after settling contains suspended particles only up to 0.3 mm in diameter. This shows that good settling takes place in the septic tank, and that it is working as intended.

FIGURE 15. Particle size distribution in the raw wastewater inlet and the septic tank at the sampling point.

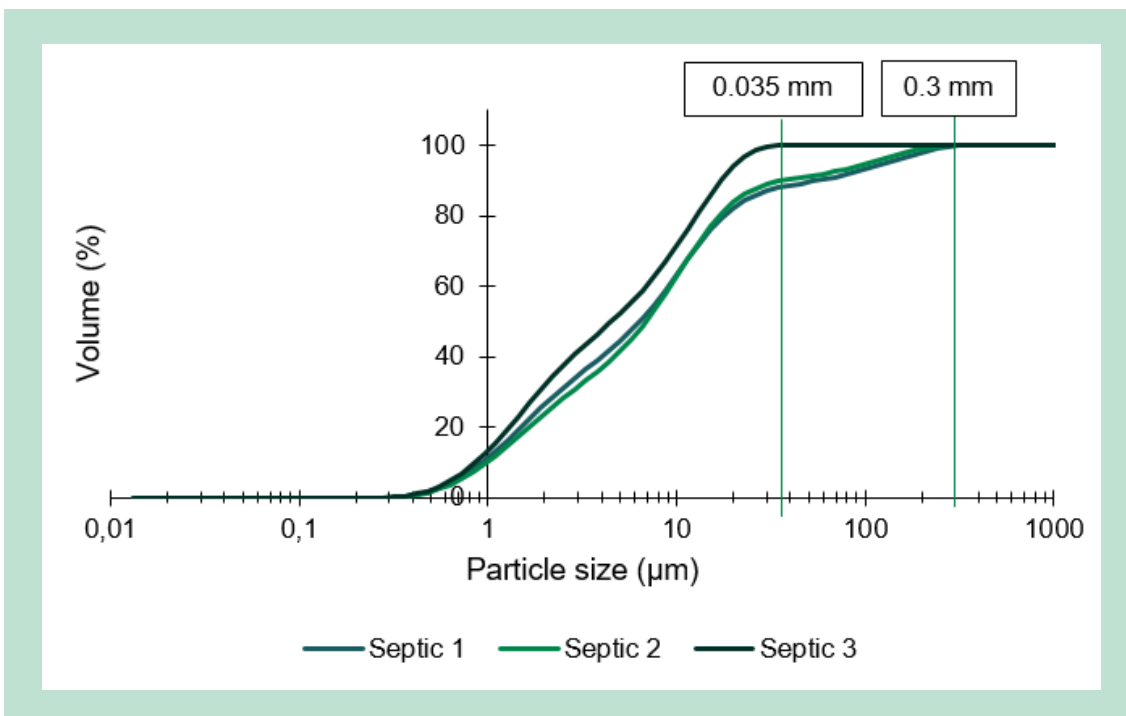
The particle size distribution of three samples, taken at various positions in front of Filter1, are shown in FIGURE 16. Sampling points Septic 1 and 2 are similar to chamber 1 with maximum particle size around 0.3 mm, whereas Septic 3 has a much lower maximum particle size around 0.035 mm. It cannot be confirmed if the sampling point for septic 3 was at a higher level, but this is what we assume happened.

FIGURE 16. Particle size distribution at three different sampling points in the settling chamber 2 in the septic tank.

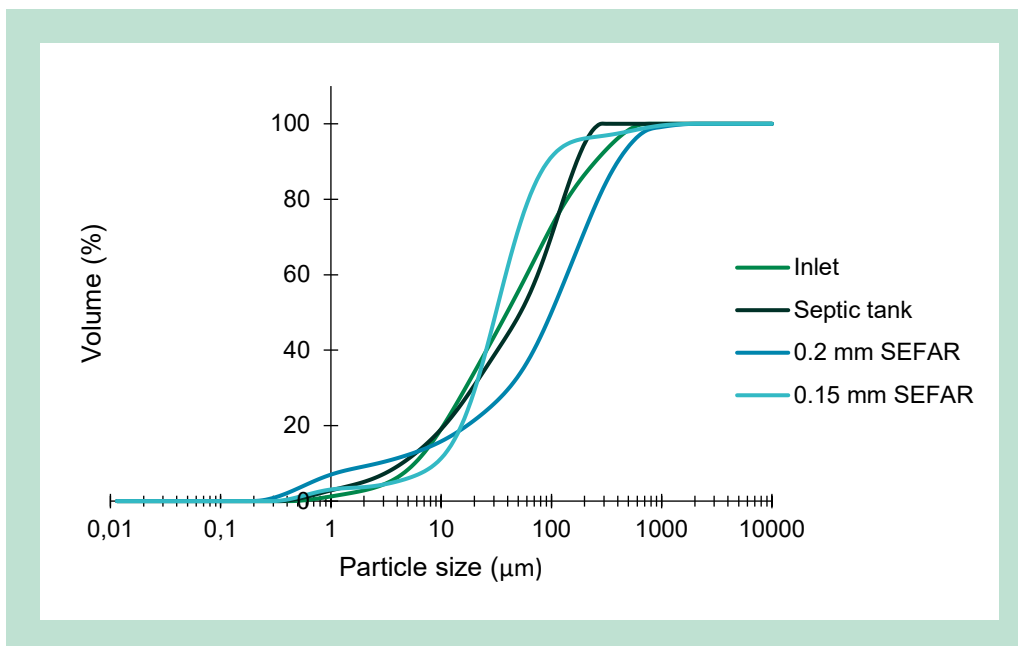
To further characterise the SEFAR filters, particle size distribution analysis was carried out. The results (FIGURE 16) after the 0.15 mm SEFAR pre-filter shows that around 95% of particles were smaller than 0.2 mm. For the 0.2 mm SEFAR pre-filter the results showed that 95% of particles are smaller than 0.6 mm. For both filters the largest particle size is around 1 mm. The results are slightly confusing, as the results shows that 5-20% of the particles after the filters are larger than the largest particle size measured in the septic tank (0.3 mm). This might be due to left over particles in the system from earlier operations, re-growth or re-flocculation of particles or uncertainties associated with probing and analysing.

FIGURE 17. Particle size distribution of the raw wastewater at the inlet, in the septic tank and after the 0.15 mm and 0.2 mm SEFAR vertical pre-filters (Filter1).

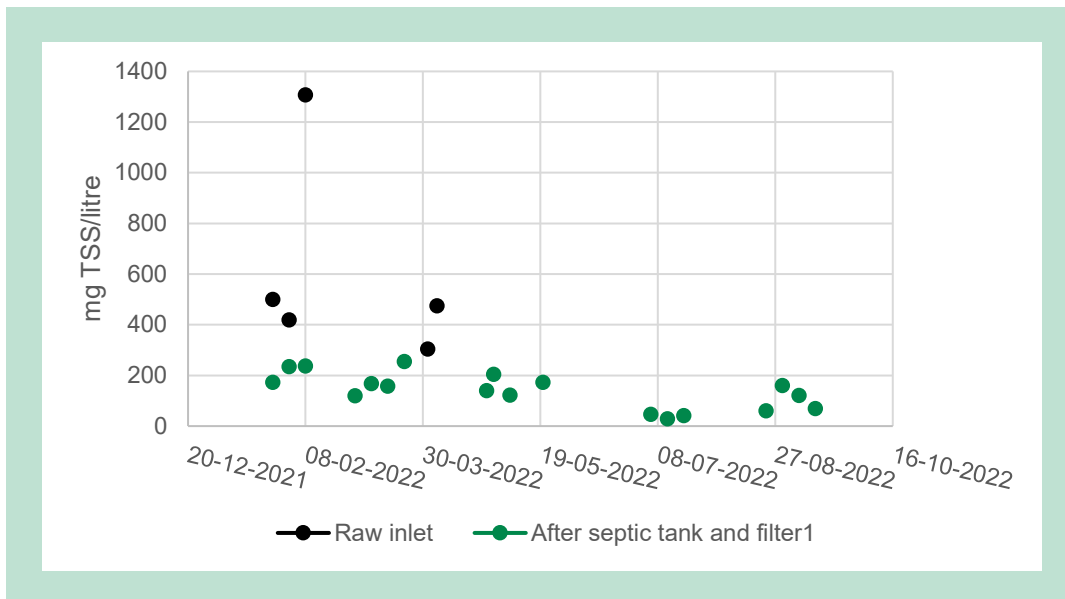
As can be seen from FIGURE 18, the typical level for TSS after the septic tank and Filter1 is around or below 200 mg TSS/L.

FIGURE 18. TSS in influent and after septic tank + Filter1 (SEFAR 0.2 mm).

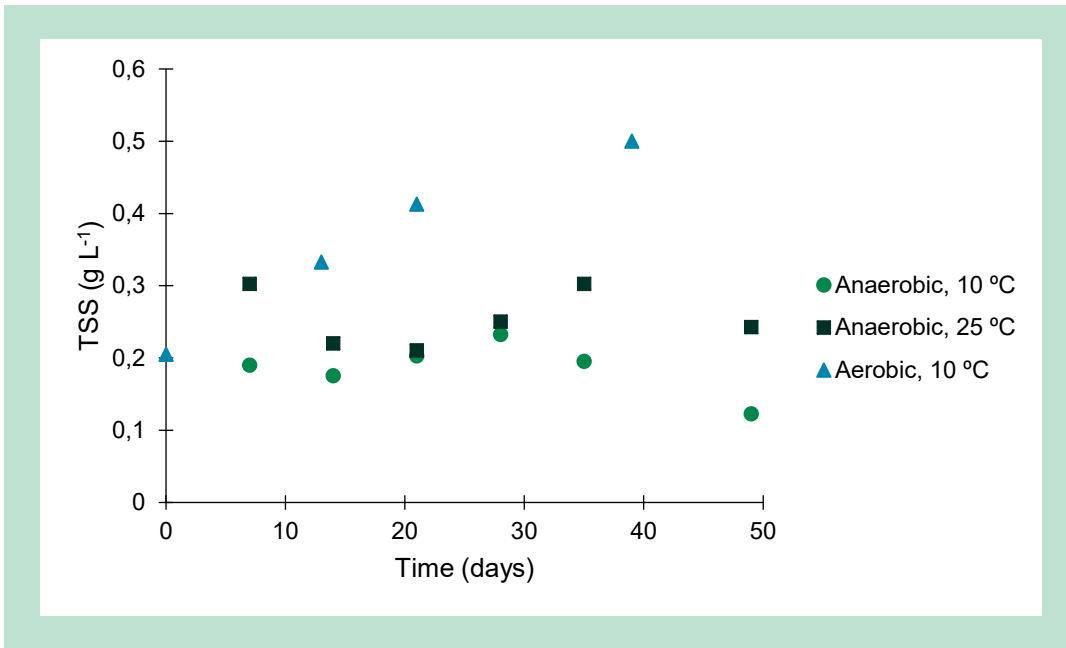
As shown in FIGURE 19, aerobic conditions seem to generate an increase in total suspended solids from 0.2 to 0.5 g L⁻¹, whereas anaerobic conditions do not seem to have any significant impact.

FIGURE 19. Development in total suspended solids over time.

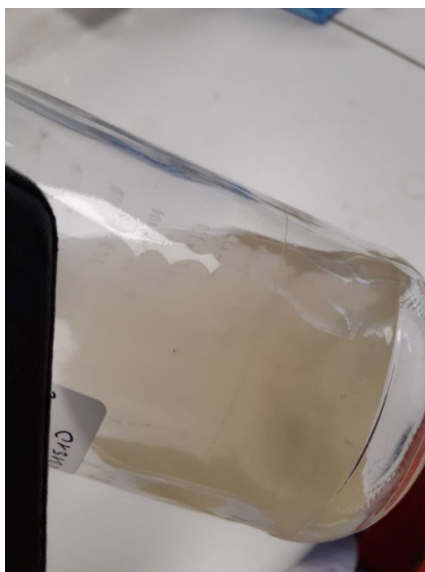
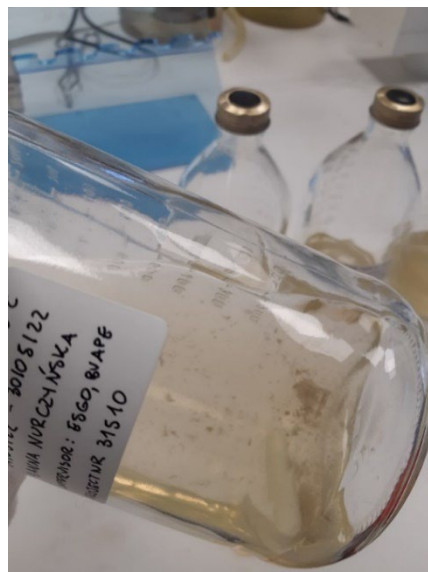
Aggregates were observed after around 35 days of experiment (Photo 1). Yet, based on the experiments, temperature plays a less important role than oxygen to bacterial aftergrowth. FIGURE 20 shows the particle size distribution analysis for both anaerobic and aerobic conditions, which again confirms that aerobic conditions seem to generate more growth than anaerobic conditions, but also into larger particles. Higher temperature promotes also larger aggregates.

Aerobic/35 days/10 °C

Aerobic/35 days/25 °C

Images of the regrowth experiment.

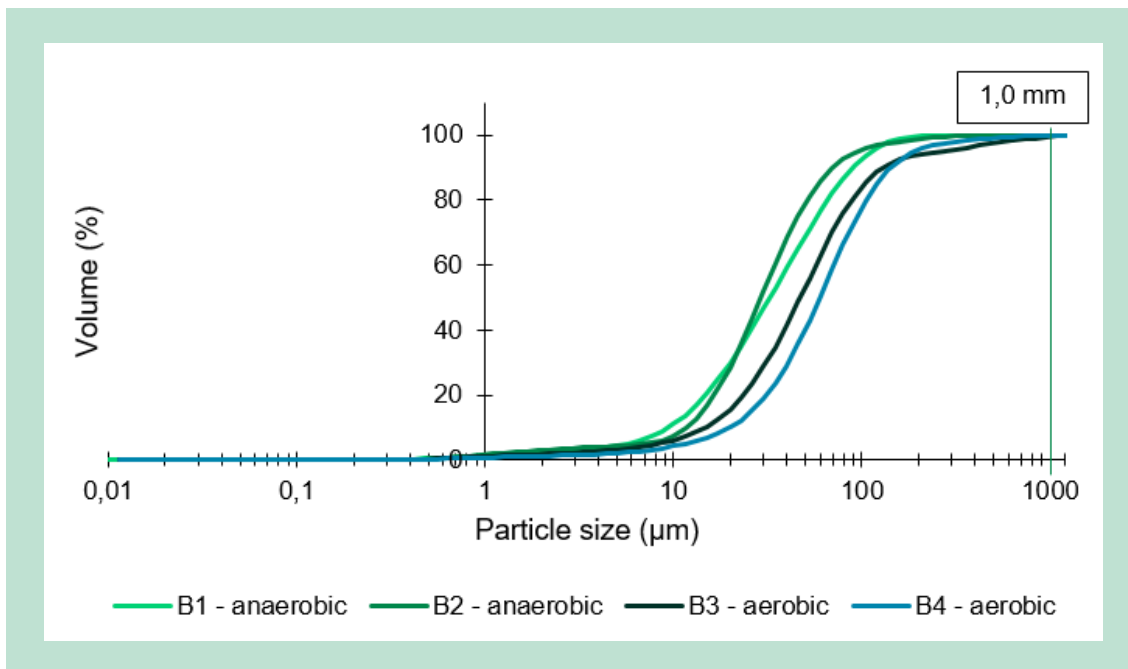
FIGURE 20. Particle size distribution analysis at the end of the regrowth experiment.

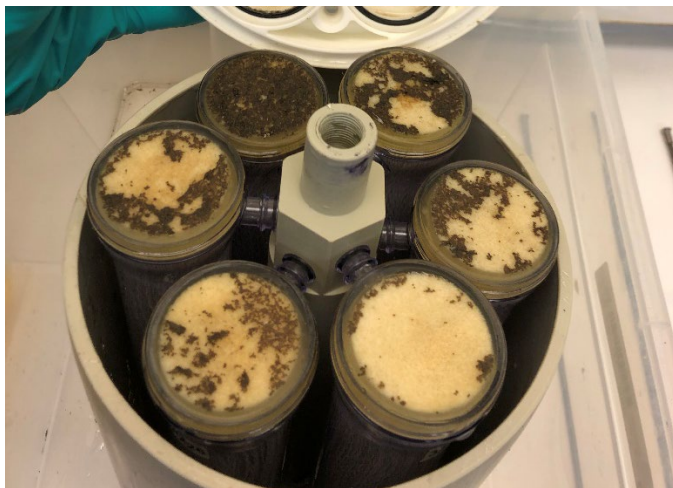
Photo 3

As 40% of the particles after the SEFAR 0.2 mm Filter1 is larger than 0.2 mm it was no surprise that this was insufficient to protect the HFFO14 with 0.2 mm hollow fibres from clogging (Photo 3). As the 0.2 mm hollow fibre FO membrane was the only one available for testing at the time, it was thus decided to implement a second pre-filtration step with smaller pore-size cartridge filters to enable further testing (Filter2).

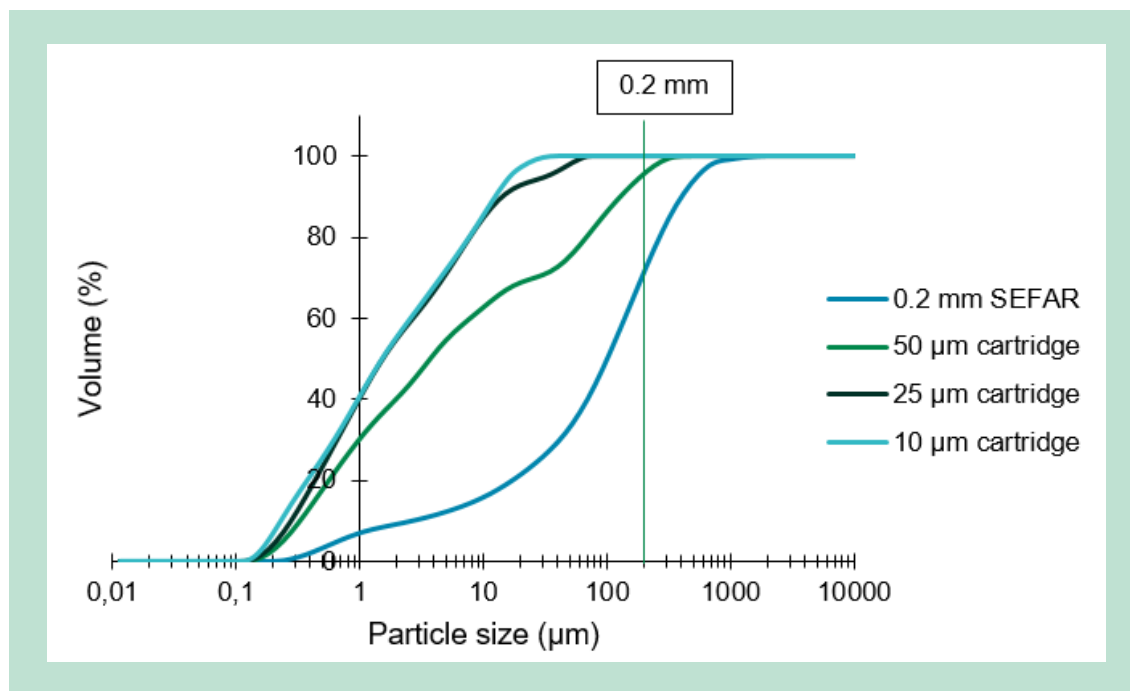
not prevented. Both the 10 µm and 25 µm filters seemed to be able to protect the HFFO14 FO membrane against clogging with the largest particle size around 0.07 mm. Though as both filters remove around 70% of the particles after the SEFAR 0.2 mm Filter1 they required very frequent replacements (few hours) to work.

FIGURE 21. Particle size distribution for the 0.2 mm SEFAR vertical pre-filter and the 50, 25 and 10 µm cartridge pre-filters.

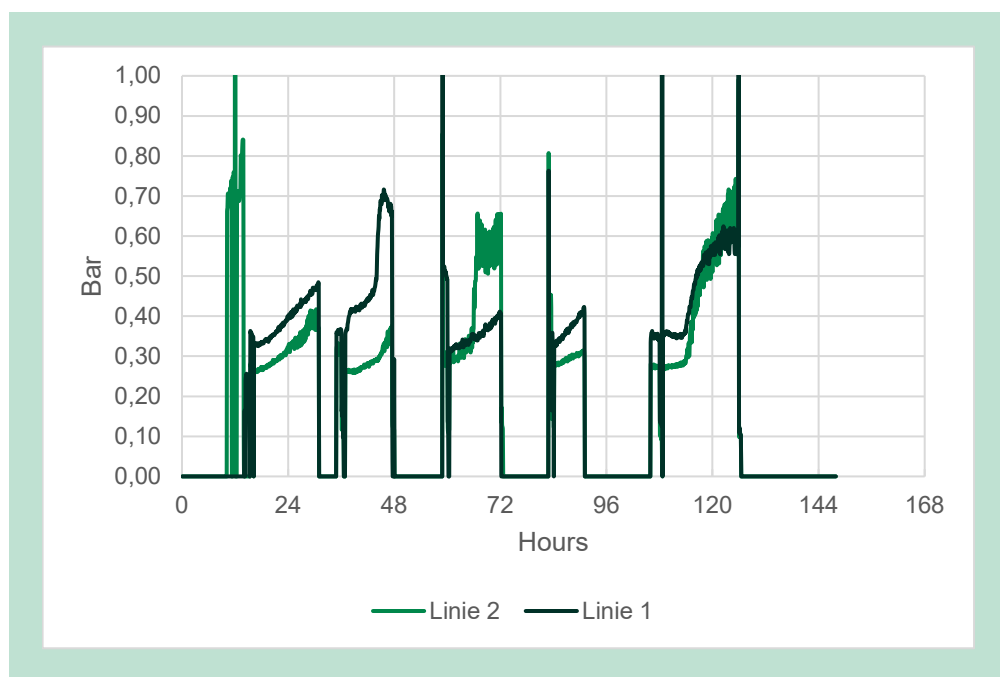
As can also be seen from FIGURE 22, relaxation has a positive impact on the back pressure on both lines as the back pressure returns to the same level after the relaxation period on both lines (around 0.35 bar for Line 1 and 0.3 bar for Line 2) even after periodically high peaks up to 0.7 bar.

FIGURE 22. Head loss development over the FO membranes. All data points are normalized to 392 L/hour to be directly comparable as actual flow declines with increasing pressure. Hours since Monday 29/08/2022 at 00:00 hrs. Static pressure is 0.09 bar.

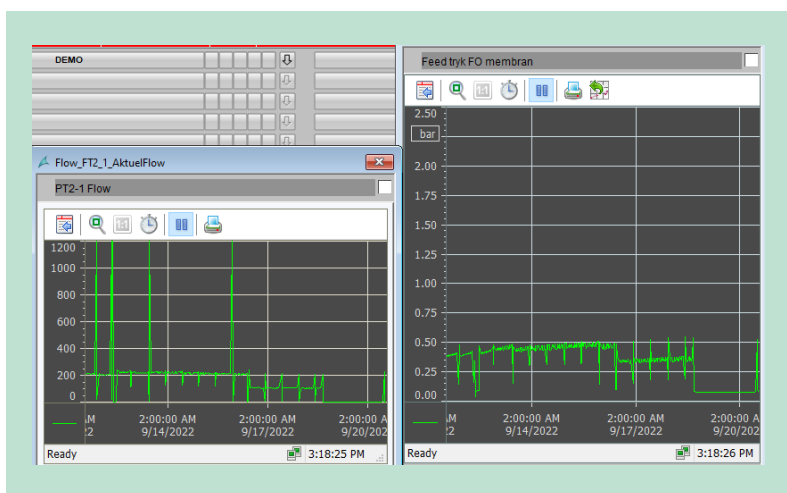
As can be seen from FIGURE 23 – period 14/9-17/9 - what seems to be a balance point was found at 200 L/hour feed flow and 2 x 30 min stop per day (due to a control error, this was not

100% relaxation as the pump still ran 10% (app. 100 L/hour) during stop sequence. Prior to the 30 min stop the FO membrane is filled with clean water via the stop-draw tank.

FIGURE 23. Flow and FO feed pressure on Line 1.

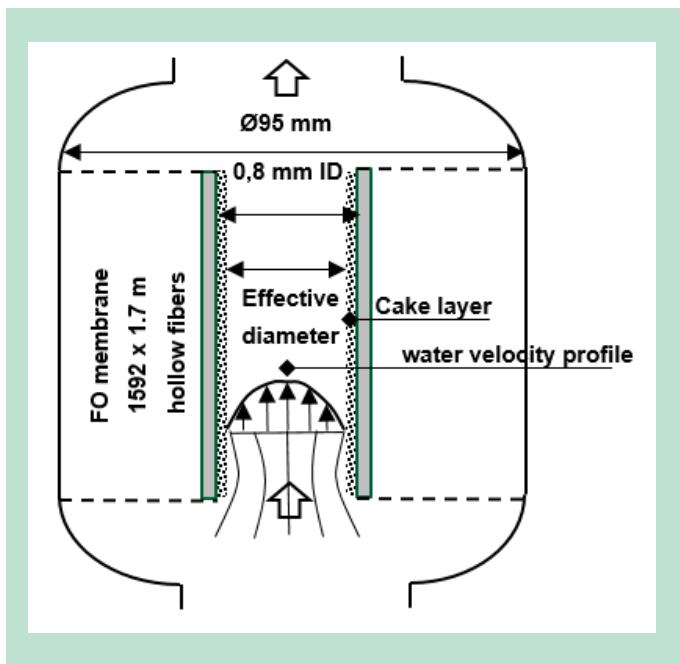
FIGURE 25 provides a schematic drawing of the feed flow side of the 0.8 mm ID FO membrane, which has been used for the head loss calculations.

FIGURE 25. Schematic drawing of the feed side of the 0.8 mm ID FO membranes.

The laminar flow conditions mean that there is very little shear force / up flow velocity to remove sediment/particles from the hollow fibers and this can help explain why sediment settle inside the hollow fibers.

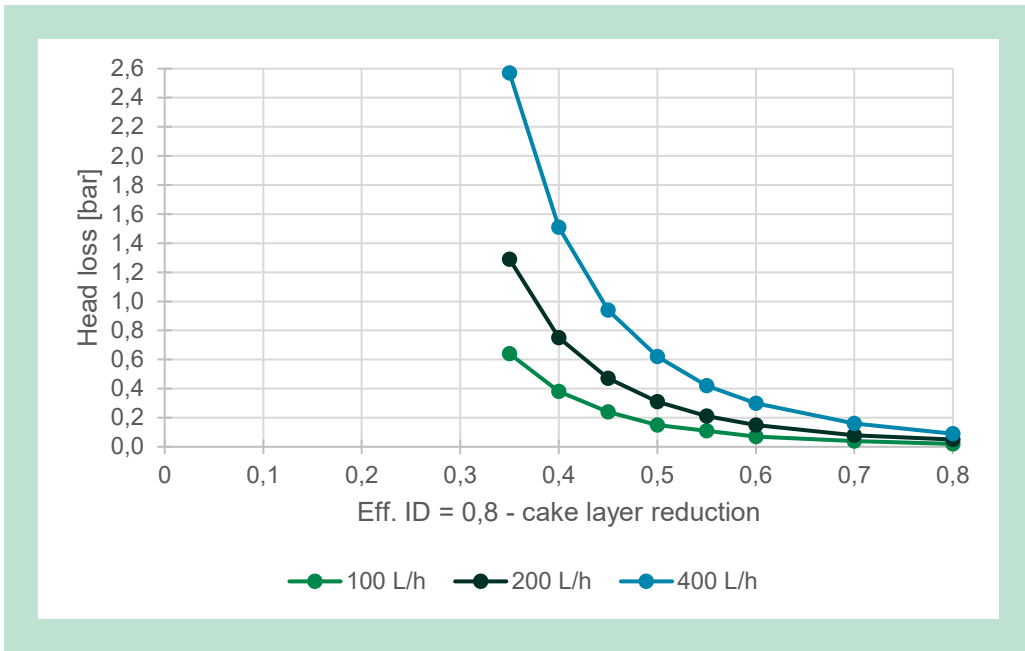
Based on the calculation model behind Appendix A, the head losses resulting from varying cake layers and feed flows has been calculated (FIGURE 26) for the FO module. As can be seen the head loss grows exponentially with increasing cake layer inside the FO membrane hollow fibers.

FIGURE 26. Calculated corresponding head loss and effective Internal Diameter for the 0.8 mm ID FO membrane at different feed flows.

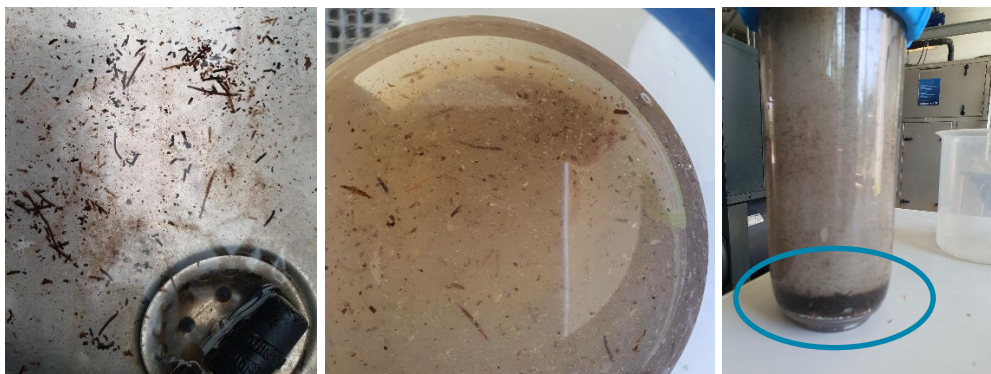
The sediment was later analyzed in the lab and the content was purely organic, which supports that the cake layer formation is caused by TSS flowing to the membrane and not from scaling/precipitations caused by reverse salt flux into the feed side.

Photo 4
Sediment from 0.8 mm ID FO membranes.

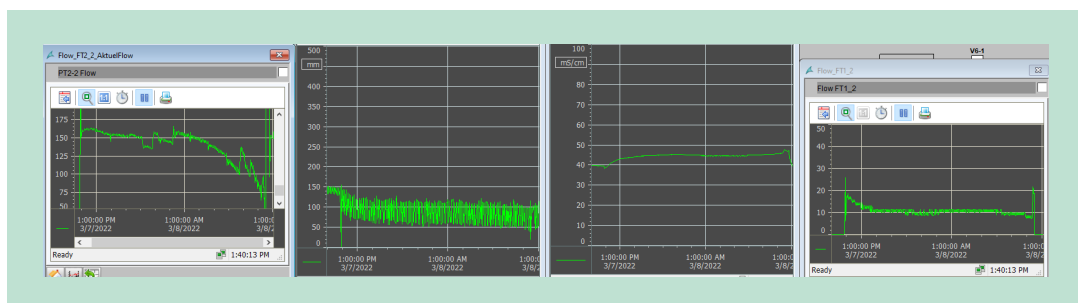
The big difference to the impression above, was that Line 2 in terms of salt concentration was starting *above* the state of equilibrium and then it was able to stabilize itself. Furthermore, it did not suffer from huge salt losses.

FIGURE 28. Screen dumps showing feed flow, draw tank level, conductivity, and outflow for Line 2.

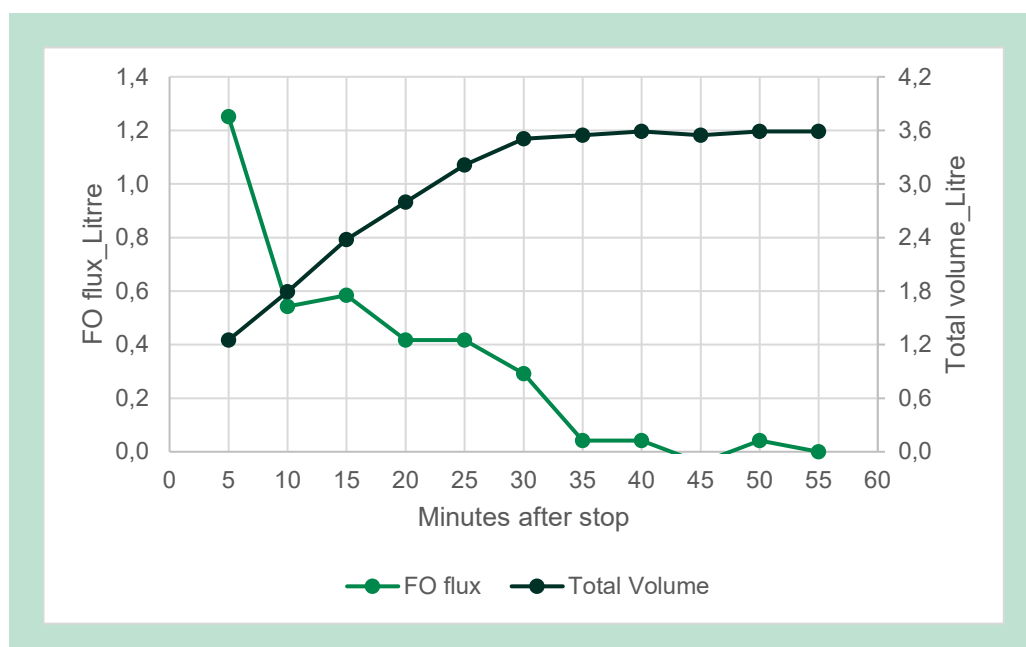
As can be seen from FIGURE 29, when the draw recirculation is stopped and the feed is replaced with water (and recirculated for 30 min), some flux will still go through the FO before the process stops completely. In all, it takes about 35 min before the process stops, and during this time a total of 3.6 Ls goes through the FO membrane.

FIGURE 29. FO flow development after stop of process on the 0.8 mm ID FO membrane 6.8 m². MgCl₂ draw solution. 9 bar osmotic pressure difference at start. Zero draw flow. Feed flow for 30 min.

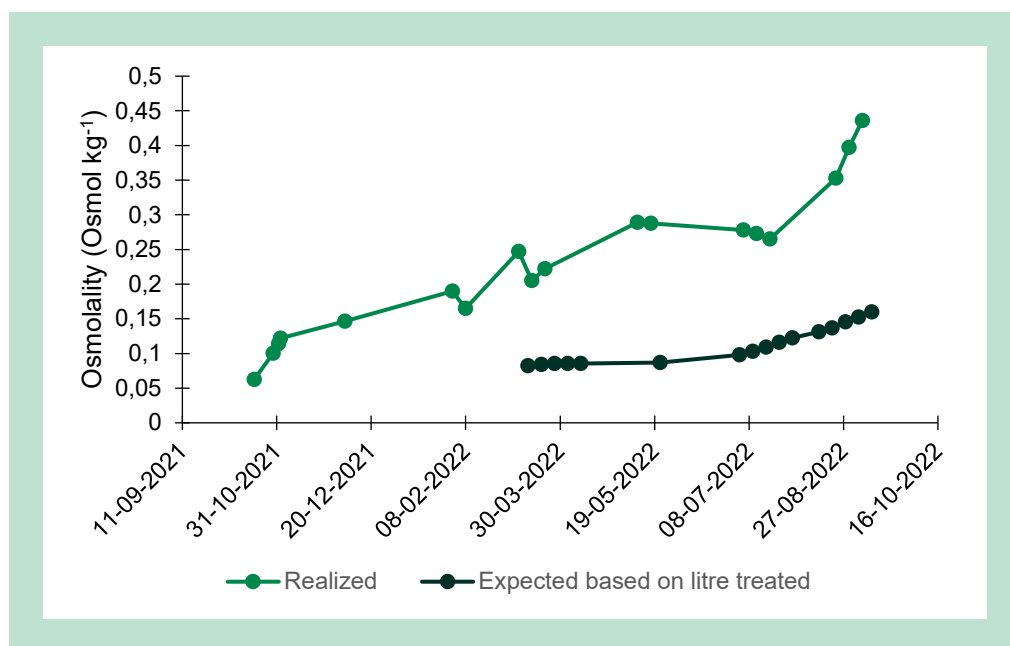
- Breaking of FO membranes in October 2021 caused draw solution to flow back into the septic tank.
- Using saltwater in the stop draw tanks and for stopping the FO membranes, continuously contributed with more salt to the septic tank. This was stopped February 2022.
- Longer periods of recirculating feed, but no permeate extraction or mismatch between the two will also cause a misbalance in FIGURE 18.
- Higher than expected reverse salt fluxes (higher than in the lab test) will send more salt to the septic tank.
- FO membrane failure august 2022, resulted in extraordinary high reverse salt fluxes, which explains the peaking after this point.

FIGURE 32. Evolution of buffer tank osmolality compared to expected due to lab test and volume treated.

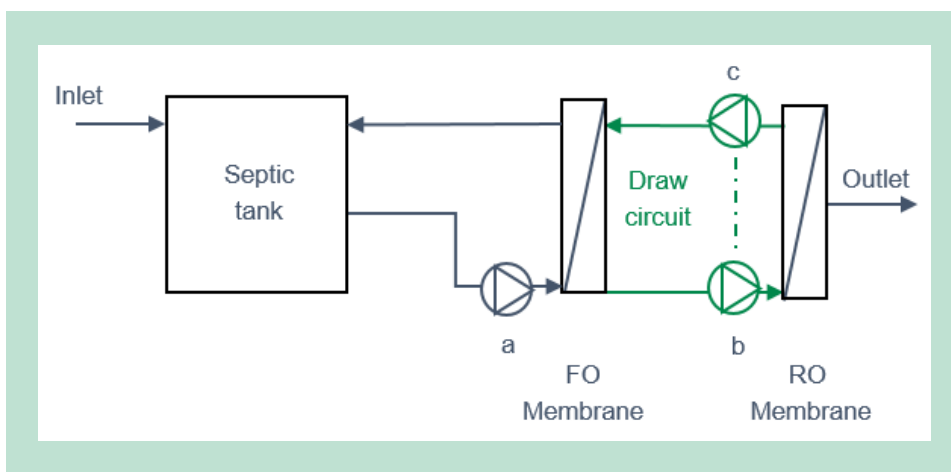
In addition to the abovementioned mechanical design issues, the power consumption will be low in the beginning of a cycle, as the osmotic pressures are low, and highest at the end of cycle, where the osmotic pressures are high. The realized average kWh/m³ power consumption will therefore depend on the amount of m³ treated. For an average Danish family with 2,15 persons this is around 80 m³ per annum, whereas summer houses are around 30 m³ per annum. At present it is therefore not possible to come up with a better and more precise power consumption of the final system than already stated.

FIGURE 33. Plant diagram with main components.
