The non-biological on-site treatment sys- tem

Final report for MUDP project

MUDP Report

February 2024

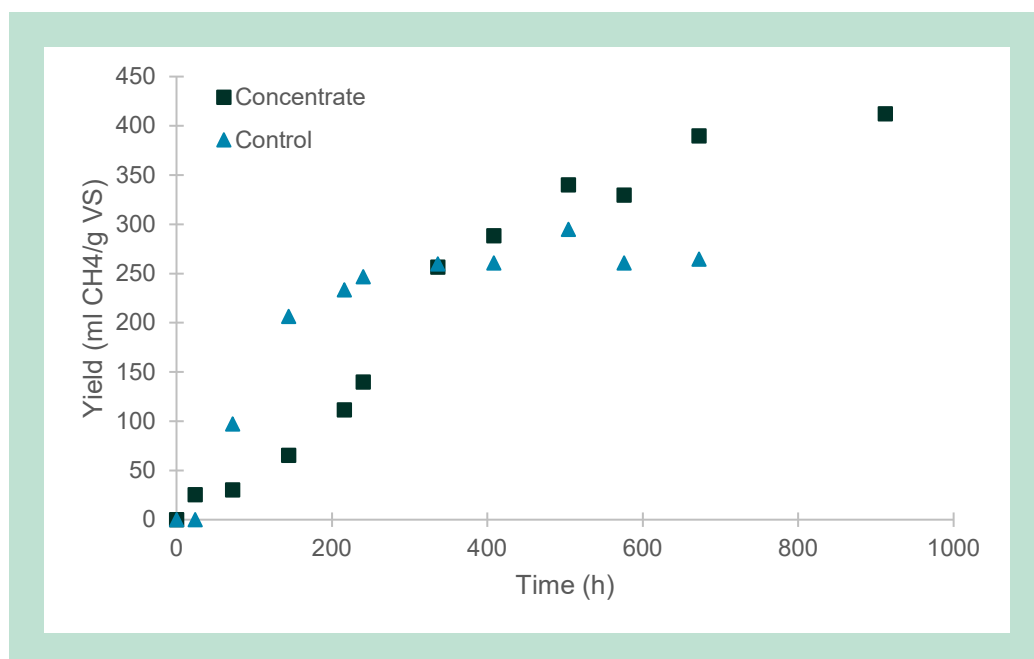
The biomethane production potential (B_{∞}) was estimated to 648 mL CH₄ g VS⁻¹, which is significantly higher than levels commonly reported for secondary sludge from municipal wastewater treatment plants (around 200 mL CH₄ g VS⁻¹) [7].

FIGURE 34. Methane production per gram of added volatile solids (VS) as a function of time

The biomethane potential of the concentrated sludge after 99% water recovery was measured to 648 ml CH₄ gVS⁻¹, which is much higher than the typical levels around 200 ml CH₄ gVS⁻¹ reported for municipal secondary sludge. The tests show an overall very low biological activity level in the septic tank, both anaerobic and aerobic. This indicates a low degradation of the biomethane potential over time.

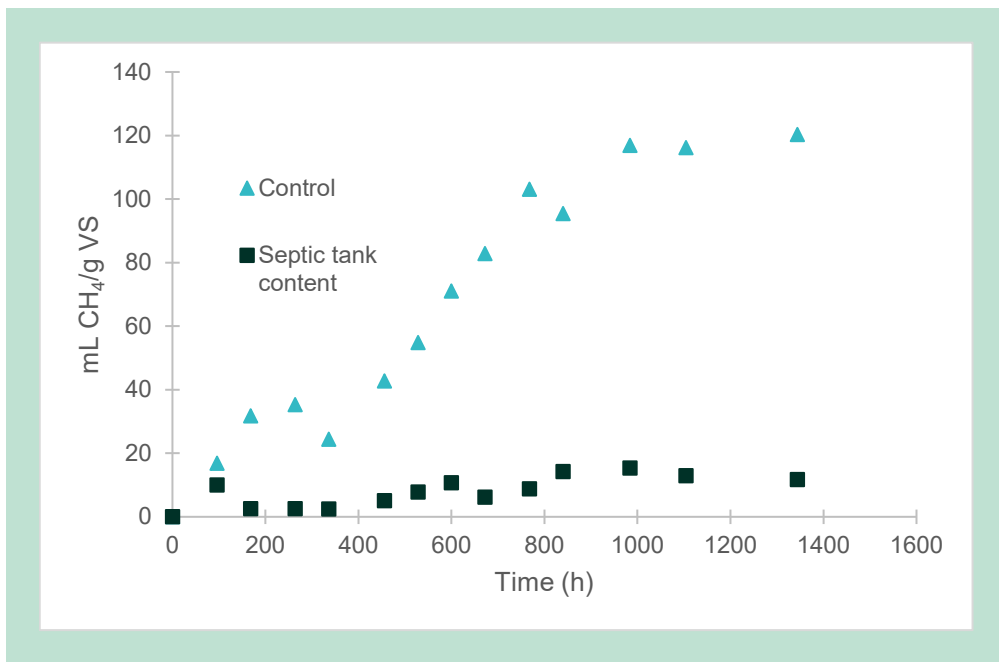
FIGURE 35. Methane production per gram of added volatile solids (VS) as a function of time.
