64021-2082 DIGITAL PV DIGITALISATION OF PV OPERATIONS

Final report
June 2024

1. Project details

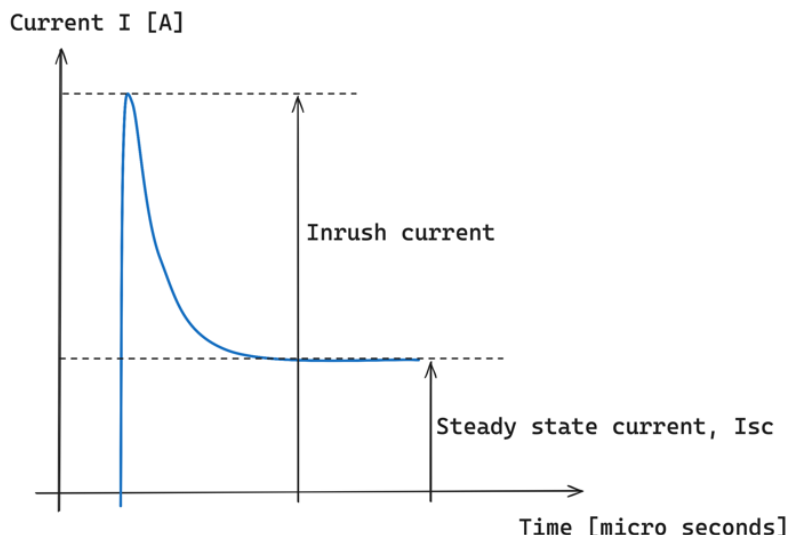
Figure 1 Simple illustration of a PV module inrush current. Due to a high capacitance in the high efficiency modules, there often is an inrush current during the first short time interval, when e.g. a current test is carried out. This inrush current can severely damage such components as the msr_engine if it is not properly protected.

A challenging aspect has been to deal with the high efficiency (HE) modules. High efficiency modules have high capacitance which can cause errors when measuring currents and switching strings in and out of inverters and combiner boxes. The capacitance can also cause a large in-rush current which can pose challenges for electronics associated with the PV system.

The magnitude of diffusion capacitance can reach the microfarad range for high efficiency modules.

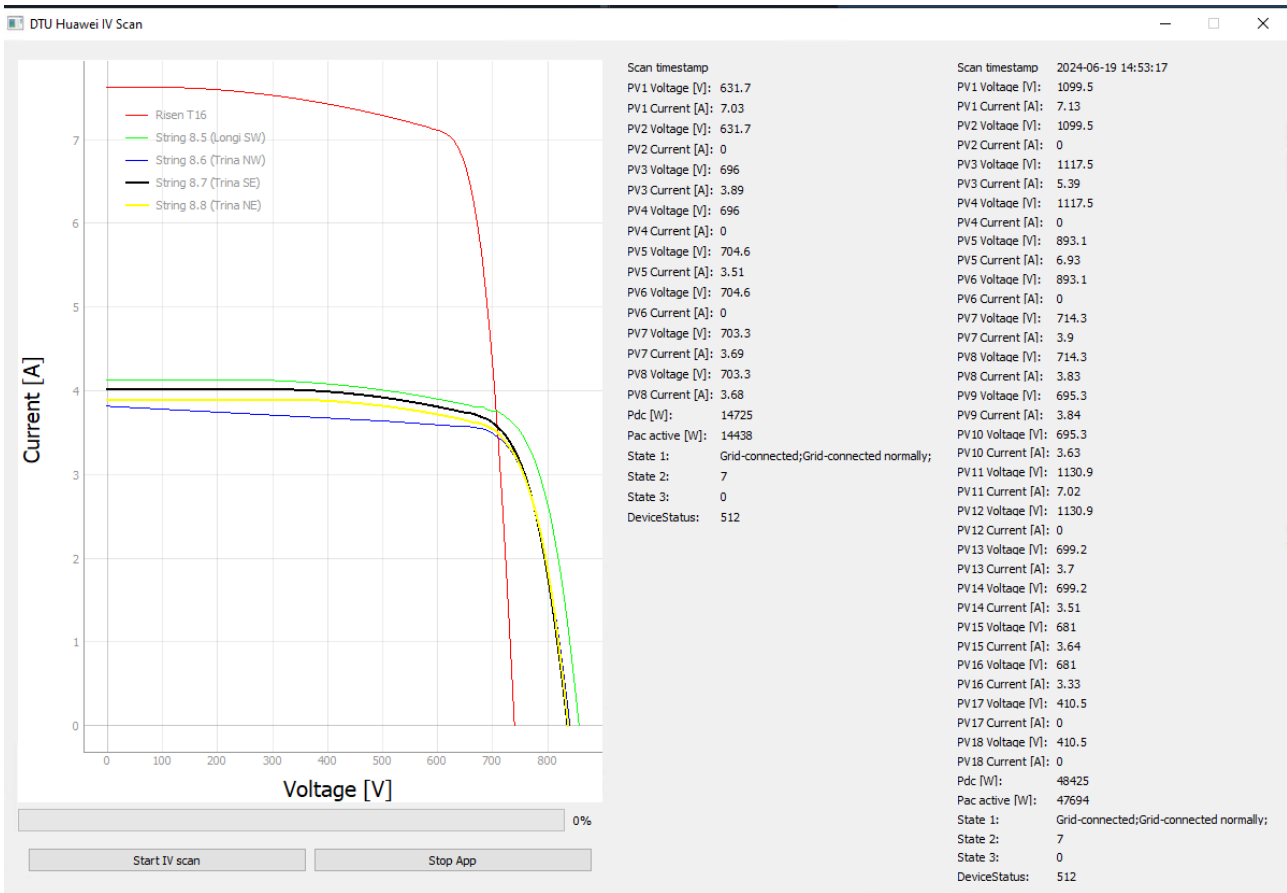
Figure 3. The graphical user interface of the developed digital interface application to Huawei PV inverters for acquisition and monitoring of string IVs.

The digital interface was tested in the field using the two Huawei SUN 2000 utility-scale inverters deployed at DTU, a 40 kW inverter connected to five PV strings and a 185 kW inverter connected to 12 strings. Figure 3 shows the application's graphical user interface, where inverter IV scans can be triggered, acquired, and displayed, together with the current electrical measurements of each string and the status of the two test inverters.

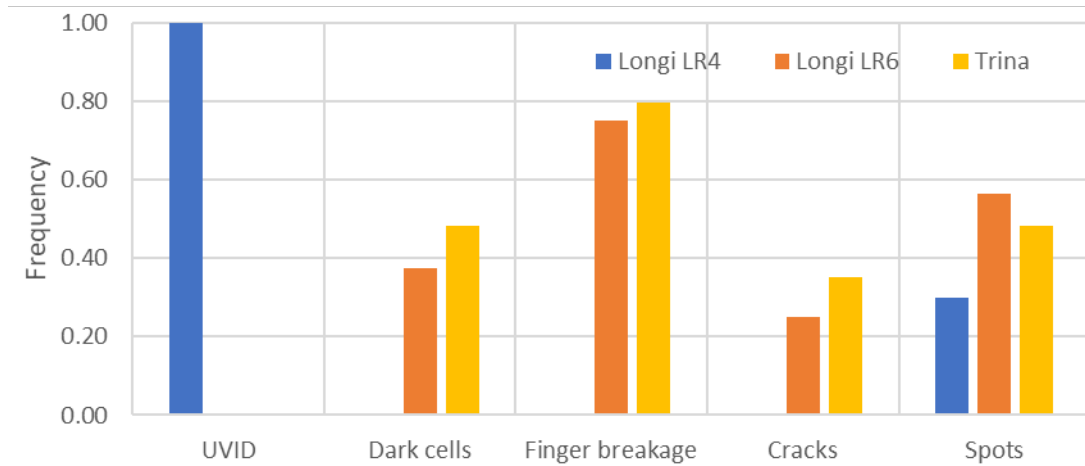
Figure 10: Frequency (number of affected modules relative to total number of inspected modules per batch) of common faults observed in EL images per module type.

EL images reveal different well known and rather unknown failure modes, an overview of which is shown in Figure 10.

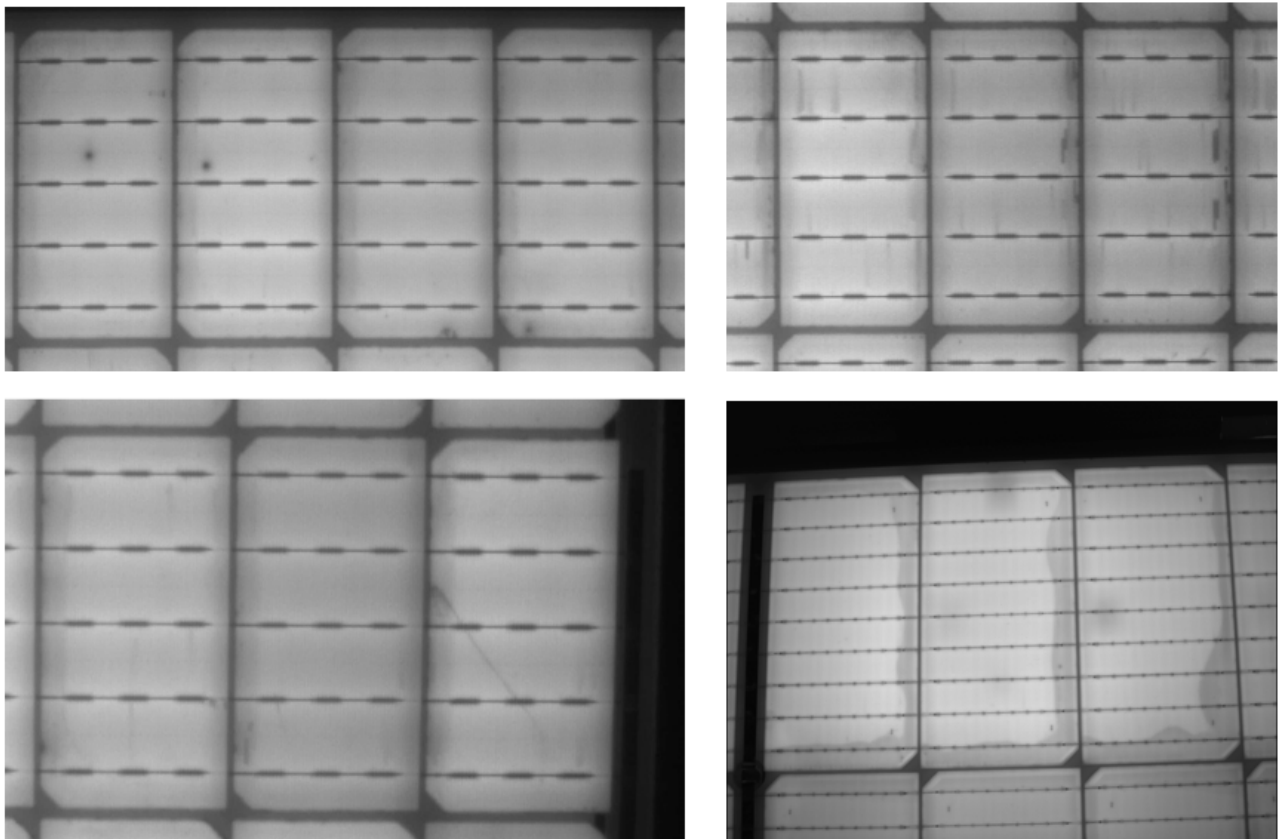
Figure 11: Top left: Spots on a Longi LR6 module; Top right: broken grid fingers on a Longi LR6 module; Bottom left: line crack on a Longi LR6 module; Bottom right, UVID type imprint in a Longi LR4 module.

While dark cells (cell mismatch), finger breakage, cracks and spots are well known failure modes, however the type of UVID (UV induced degradation) we observed in Longi LR4 modules is not well described in the literature. Figure 11 shows visual impressions of EL images capturing different failure types.

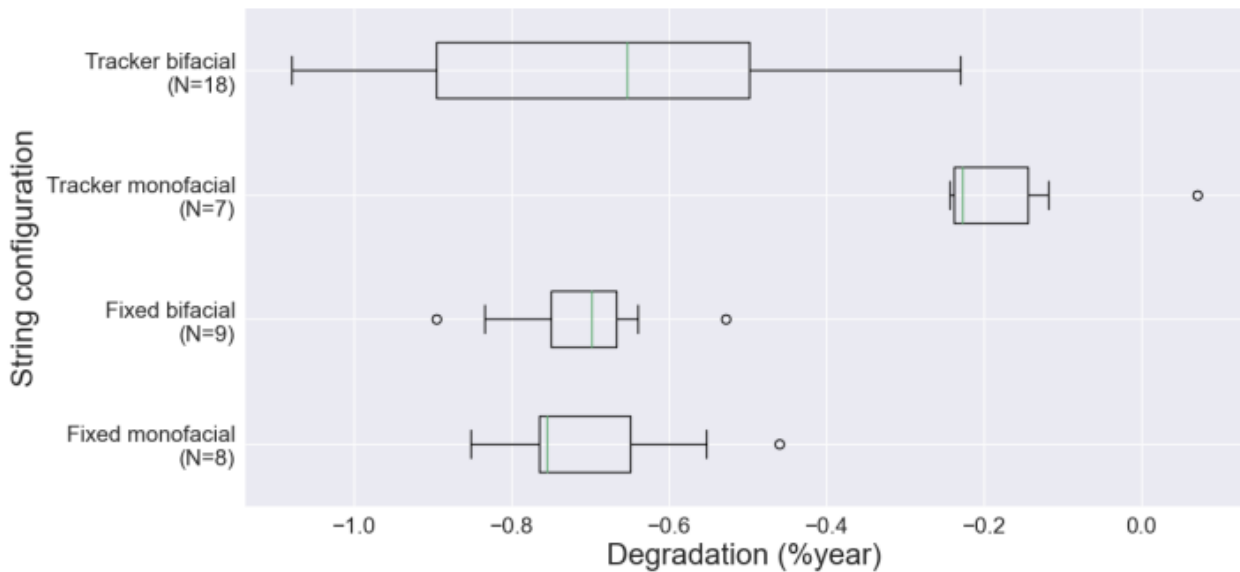
Figure 12. Box plots showing distributions of degradation rates calculated for 42 individual bifacial and monofacial strings installed at DTU Risø. Medians are represented with green lines. Figure credit: Raul Alcacer Galan's MSc thesis.

Overall, the median degradation rate (Rd) of the 42 bifacial and monofacial PV strings shown in Figure 12 is -0.65%/yr. Considering the uncertainties of the year-on-year method, this result is in close agreement with the Rd published in peer-reviewed studies on legacy PV modules^{3,4}.

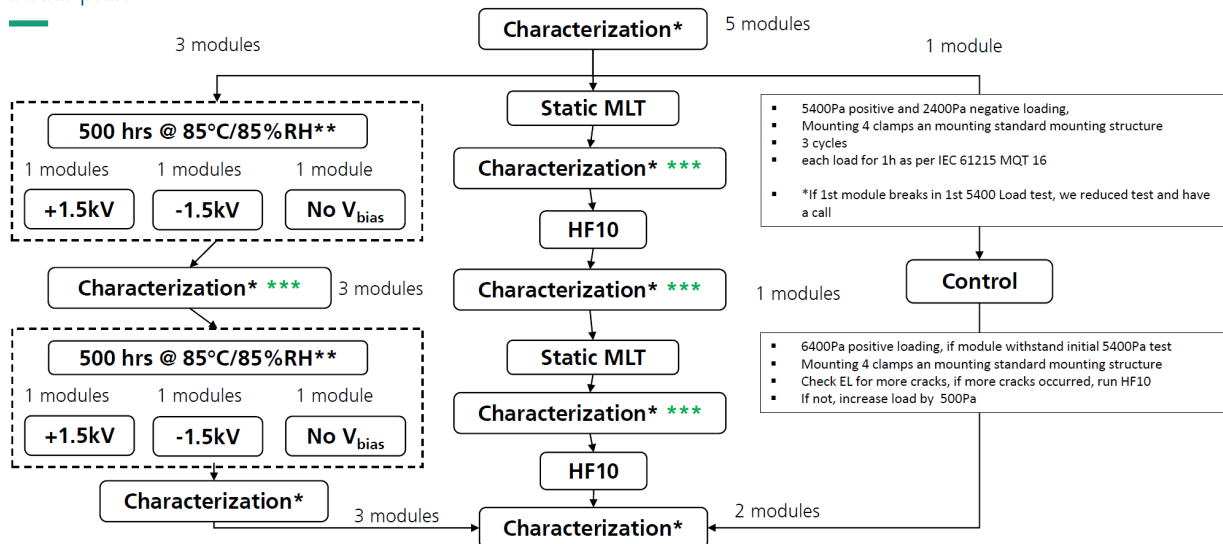
Initial plan

*Front I-V at STC and 200 W/m² and EL imaging @100% and 10% Isc
 **In situ Dark I-V on selected modules every 3-4 days, 1st IV after heating up
 *** intermediate characterization without VISUAL

As part of the degradation investigation, we contracted the German research institute Fraunhofer CSP to conduct and report on "Accelerated Module testing for PID and Mechanical load" of 24 PV large format PV modules according to the following test plan, shown in Figure 13.

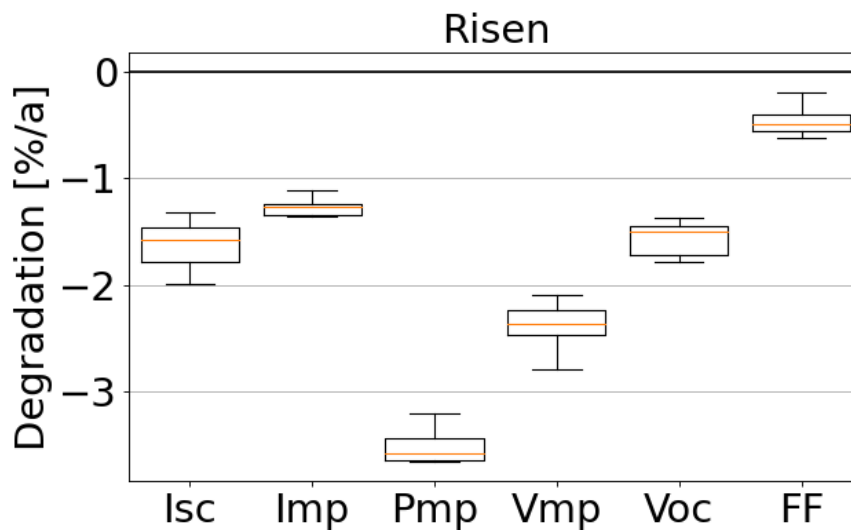
Figure 14: Annual degradation rate of I-V parameters from flash tests at standard testing conditions on the front side compared to data sheet specifications of the Risen modules. The orange line shows the median value, the box covers the 25th to 75th percentile and whiskers show the rest of the spread excluding outliers.

We tested 16 current generation Risen RSM-595 modules for degradation after two years of field exposure with the methods described above, using indoor IV flash test and EL imaging. Figure 14 shows the annual degradation of the IV parameters of this module type. It displays much higher degradation than the other three module types tested, reaching an annual degradation rate of 3.5% per year at the maximum power point. Losses seems to stem equally from current losses (at I_{sc} and I_{mp}) and voltage losses (at V_{oc} and V_{mp}). The fill factor is affected the least, which hints for stable series and shunt resistance of the modules.

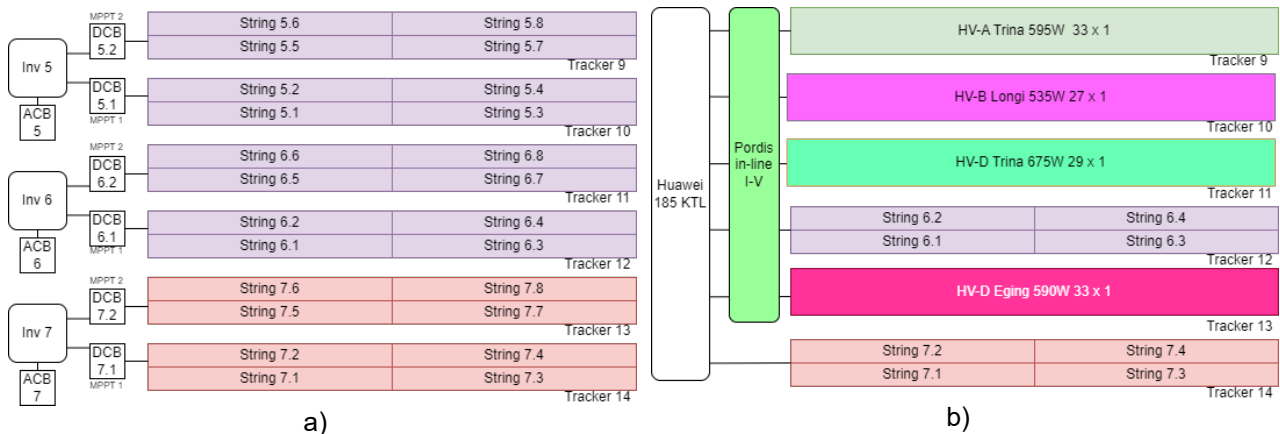
Figure 16. Layout of the DTU Risø PV farm, south oriented field: a) before retrofit; b) after installation of the new Huawei inverter and new digital string monitoring box (Pordis), both capable of string IV curve monitoring, as well as the deployment of four next-generation large format/high voltage PV modules for long term performance testing.

To assess the long-term reliability of the large format PV modules, and in complement to the accelerated stress testing performed at Fraunhofer, we deployed four types of next-generation PV modules at the DTU Risø PV farm. A total of 122 large format modules were deployed in four high voltage (1500 V) PV strings, depicted in Figure 16b as HV-A, HV-B, HV-C, and HV-D.

This required retrofitting of the existing PV trackers (depicted in Figure 16a and Figure 17a), initially deployed in 2018, and the decommissioning of approx. 300 modules, half of which were characterized in the laboratory as part of a bifacial PV module degradation study, that is currently in preparation.

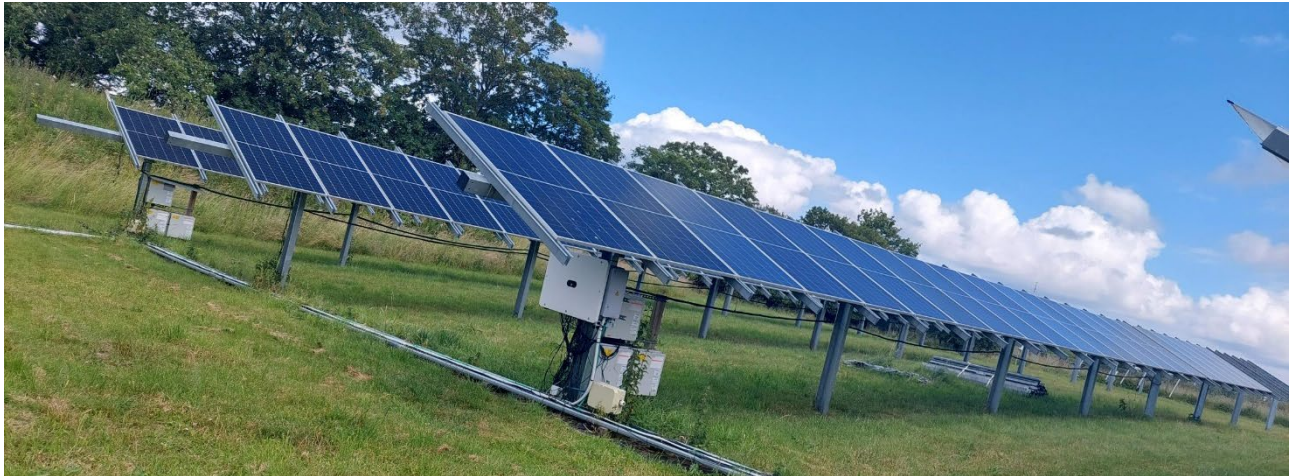
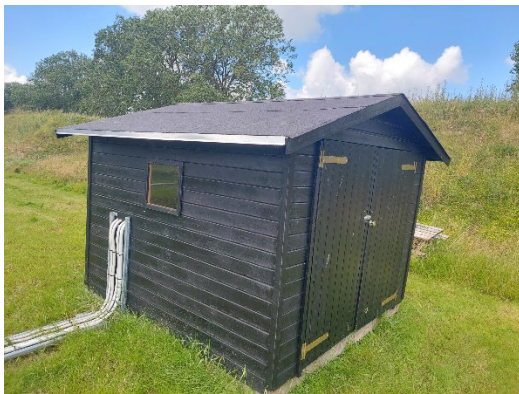
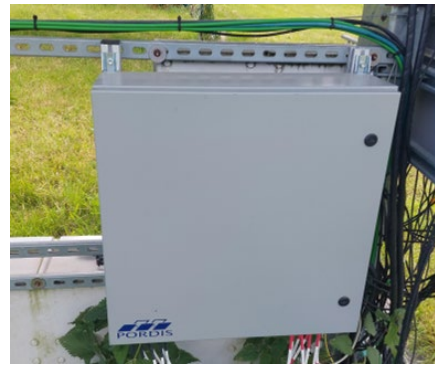
a)

b)

c)

The deployment of high voltage PV strings was also required, as well as the replacement of the existing PV inverters, which were only rated 1000 Vdc, with a current generation utility-scale PV inverter rated for 1500 Vdc. However, such an inverter requires an 800 Vac grid connection, whereas DTUs electrical grid is designed for 400 Vac. This required the installation of an additional high-power transformer shown in Figure 17b.

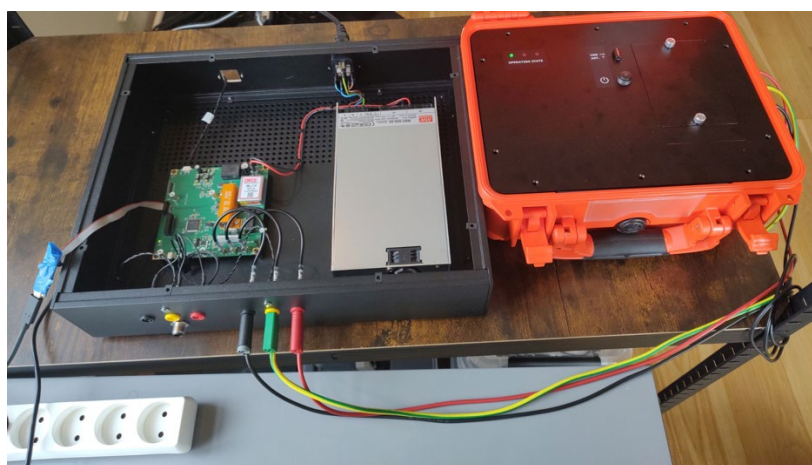
Figure 23 Calibration box designed and built for calibration of the msr_engine.

To assure the precision and accuracy of measurements carried out with the msr_engine, we developed a new device for calibration. In the photo below we see the calibration electronics which was designed and built entirely for the project. The calibration box (P-box) is fully functional and based on. The same main MCU architecture, firmware and user interface as the msr_engine. This will allow a potential industrialisation of the combined technology package.

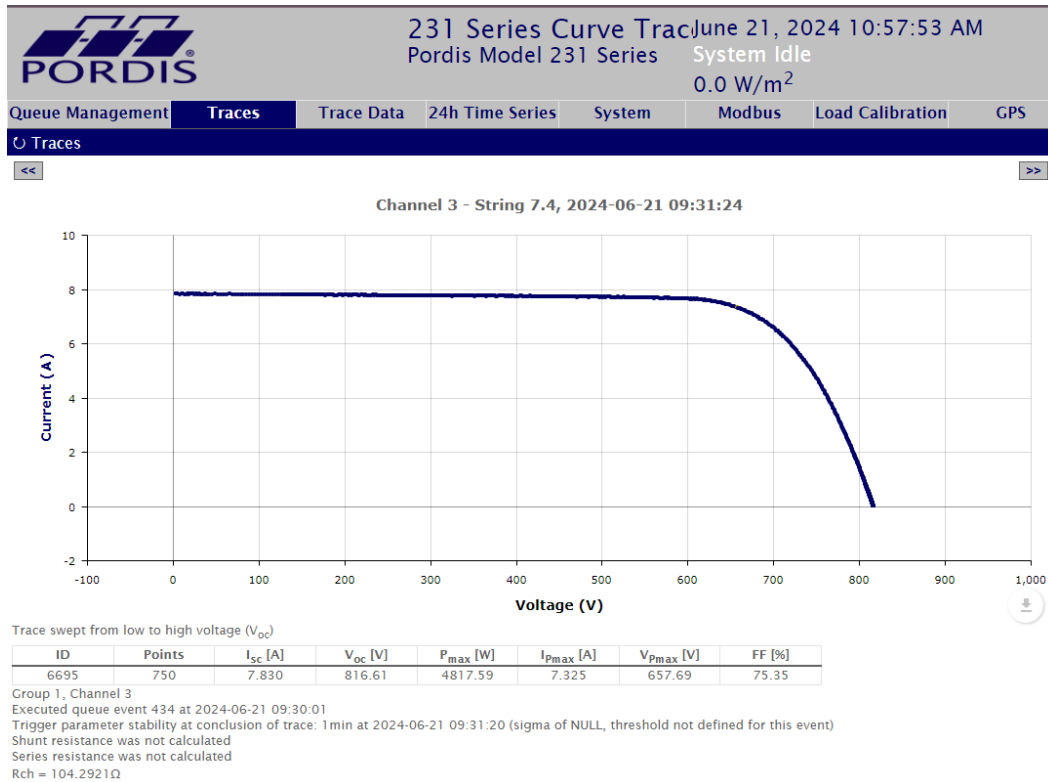
Figure 24. Example of string IV measurements acquired with the Pordis string monitoring box.

The system is currently operational and collecting IV data from four PV strings, initial results (exemplified in Figure 24) show excellent IV curve measurement accuracy. A study is being conducted to evaluate its IV measurement accuracy under a range of operating conditions, and the results are planned to be published at the 2024 EUPVSEC conference.

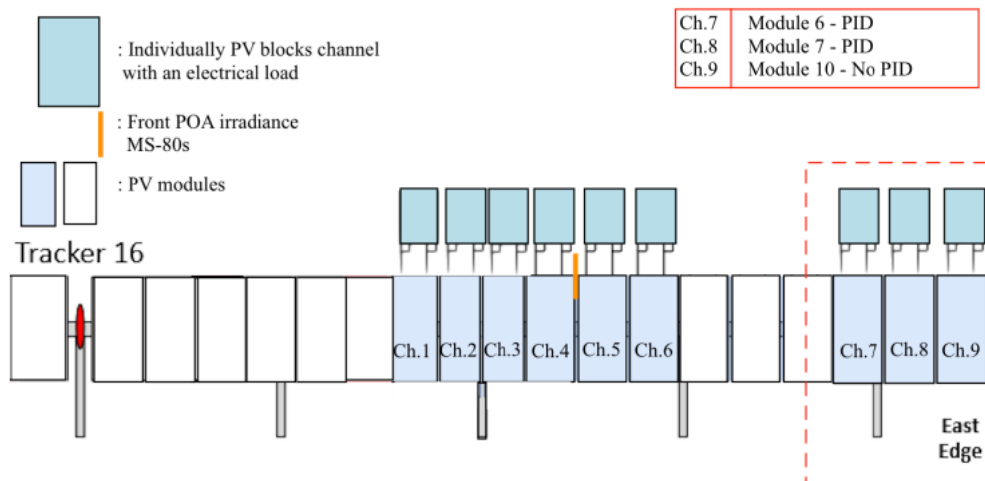
Figure 26. Field setup at DTU Risø for PV module outdoor IV characterization showing the deployment of the PID test modules on Tracker 16.

In this study, we used three mono facial PV modules, where two had different numbers of cracked solar cells (Figure 28b and c) and one (Figure 28a) was a healthy control module of the same type. The modules were deployed in the same setup, presented in Figure 26, and IV measurements were acquired over several weeks.

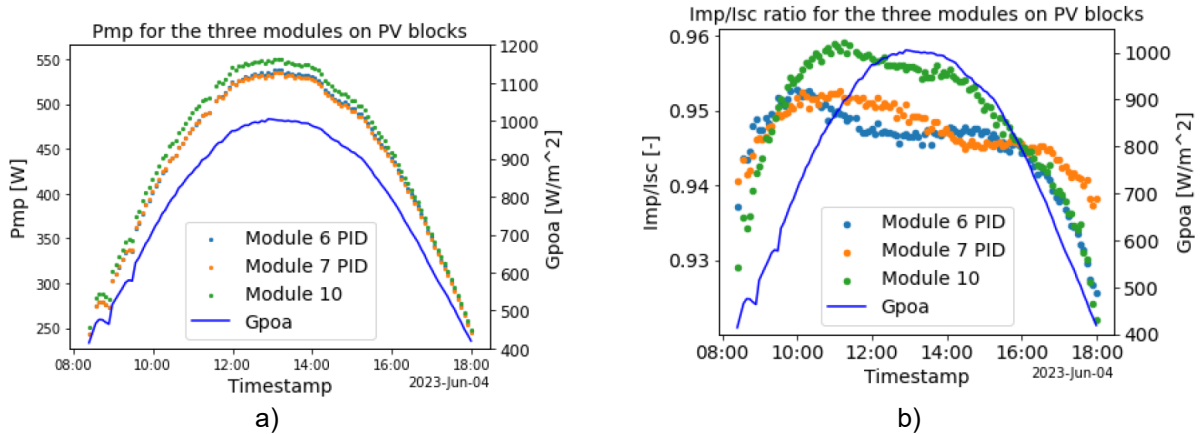
Figure 27. Detection of PID in PV modules by I_{mp}/I_{sc} (derived from IV curves) monitoring: a) Pmp throughout a clear sky day for three modules, two with PID and one without; b) The change in I_{mp}/I_{sc} ratio throughout the day for three modules, showing increased shunt resistance losses in the PID modules (6 & 7) relative to the control module (10)

monitoring. These parameters allow the calculation of diagnostic indicators such as the I_{mp}/I_{sc} ratio, that are sensitive to changes in the shunt resistance of the module, which is typically affected when PV modules are degraded by PID. Such a situation can be observed in Figure 27b, where the I_{mp}/I_{sc} ratio of the PID modules (orange and blue) has decreased in relation to the control (green), indicating the shunt of these modules has decreased as well, which is a sign of PID.
